Oversized Solenoid Switch Valve Plug Kit

92835-22K

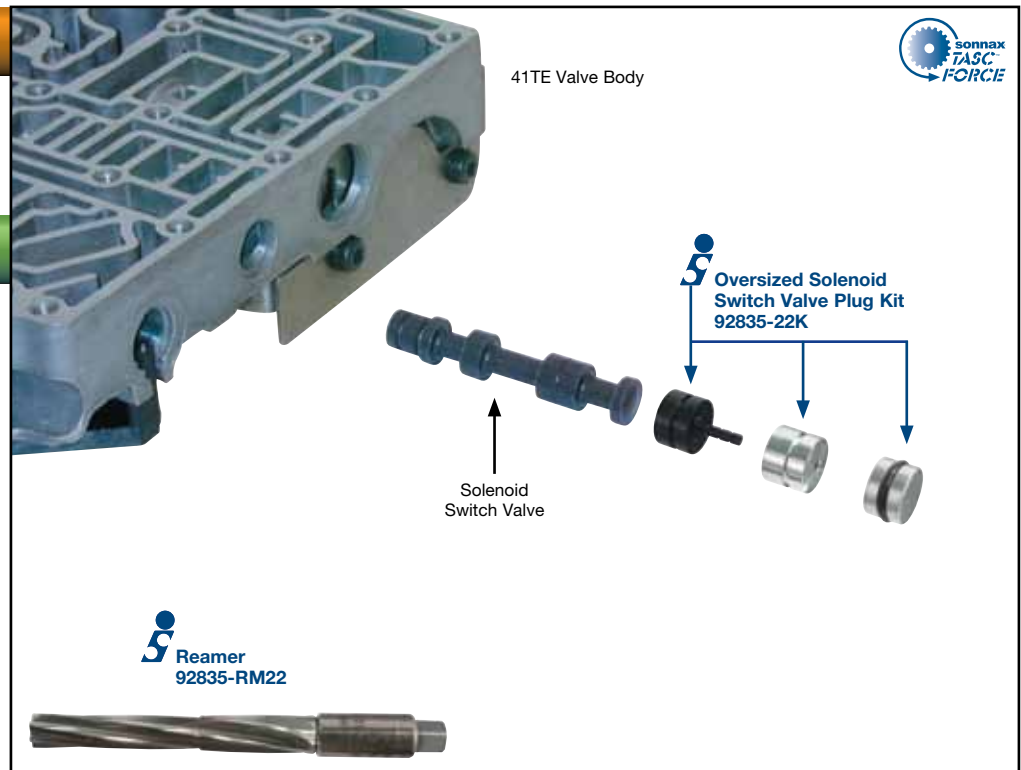
Erratic/No TCC, 2nd Gear starts

- Low reverse switch code

Solenoid switch valve plugs cocking in the bore and/or bore wear at the switch valves.

Common complaints with 41TE and 42RLE transmissions include erratic or no torque converter clutch control, second gear starts and/or low reverse switch code. These can be caused by the solenoid switch valve plugs cocking in the bore and hanging up. Another cause of these complaints can be bore wear at the switch valves due to the cocking action and/or continuous oscillation of the plugs. For VLP units with excessive wear, Sonnax offers an oversized solenoid switch valve plug kit **92835-22K** that requires reamer **92835-RM22**.

The replacement switch valve plugs feature a guide stem that connects the two halves and prevents valve cocking.

- Oversized Replacement Plugs (2)
- End Plug
- O-Ring

Reamer

92835-RM22

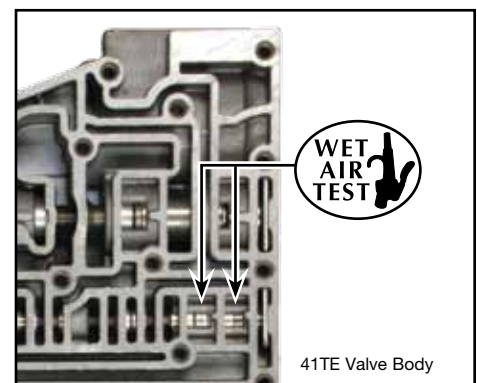
A wet air test at either indicated port produces leakage from adjacent ports or past the plugs.
