Oversized Modulator Valve & Reamer System

36833-01K

Sonnax Part Summary

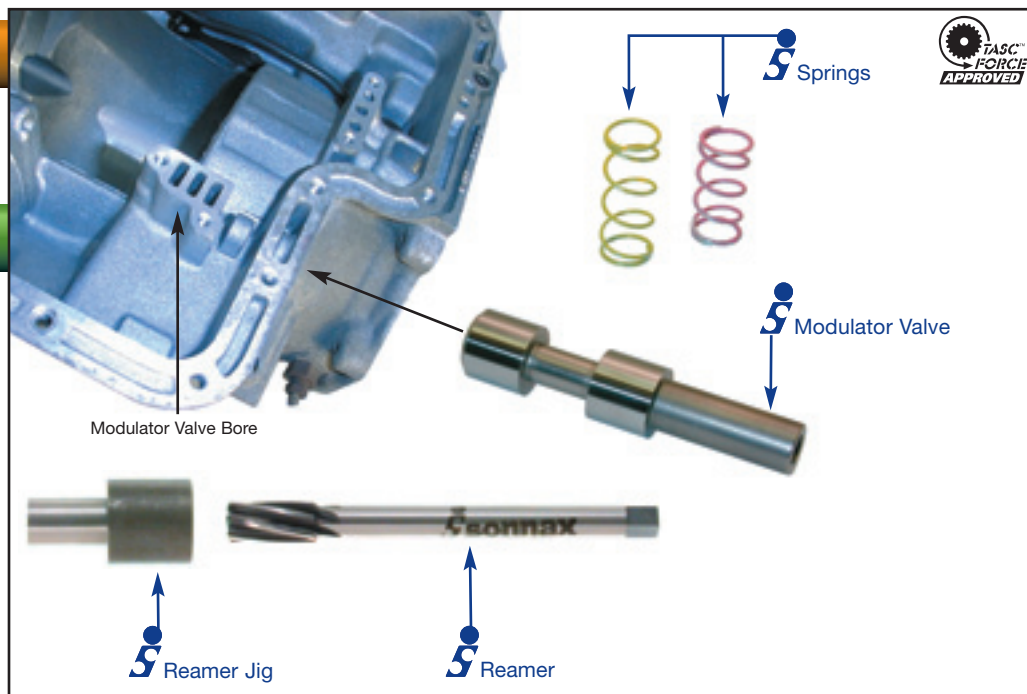
Severe wear of the transmission case at the modulator valve bore due to continuous valve oscillation.

Vehicles with a C6 transmission frequently have problems with stacked upshifts even with no vacuum at the modulator, no kickdown, poor line rise, or direct clutch failure. These problems can be caused by severe wear of the transmission case at the modulator valve bore. When excessive wear occurs, line pressure and TV pressure are allowed to cross leak and/or leak to sump. Sonnax part **36833-01K** addresses these complaints.

This slightly oversized modulator valve restores the hydraulic integrity of the circuit once the reamer and jig are used to enlarge the case bore to accommodate the valve.
