Oversized Accumulator Pressure Control Valve

36948-20K

36948-TL

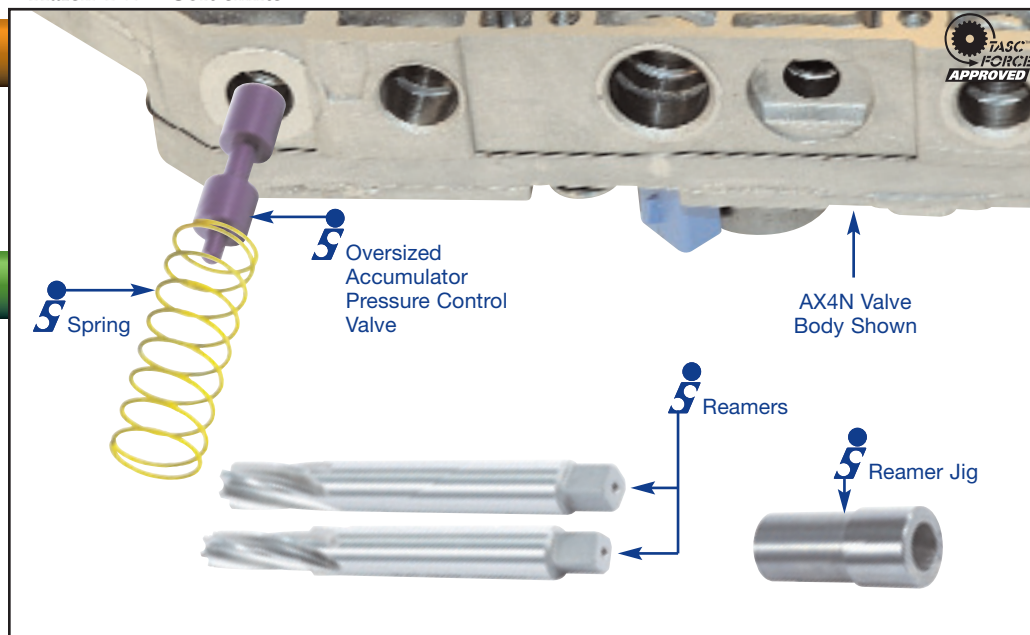
Continuous oscillation of the accumulator pressure control valve in the cast aluminum body causes bore wear, which can affect accumulator control pressure.

Continuous oscillation of the accumulator pressure control valve in the cast-aluminum body causes bore wear, which can affect accumulator control pressure. Wear at the balance port area can prevent the valve from stroking properly, which causes too much resistant pressure to the accumulator pistons and results in harsh shifts. Wear at the outboard spool can allow line pressure to leak to exhaust, resulting in decreased accumulator control pressure and soft shifts. The oversized Sonnax accumulator pressure control valve for the '95-'97 AX4N, **36948-20K**, allows the worn valve body bore to be refurbished and restores pressure control to the accumulator control pressure circuits.

The Sonnax kit contains an oversized valve that allows the worn valve body bore to be refurbished and restores pressure control.
