Pump Bushing

Sonnax Part Summary

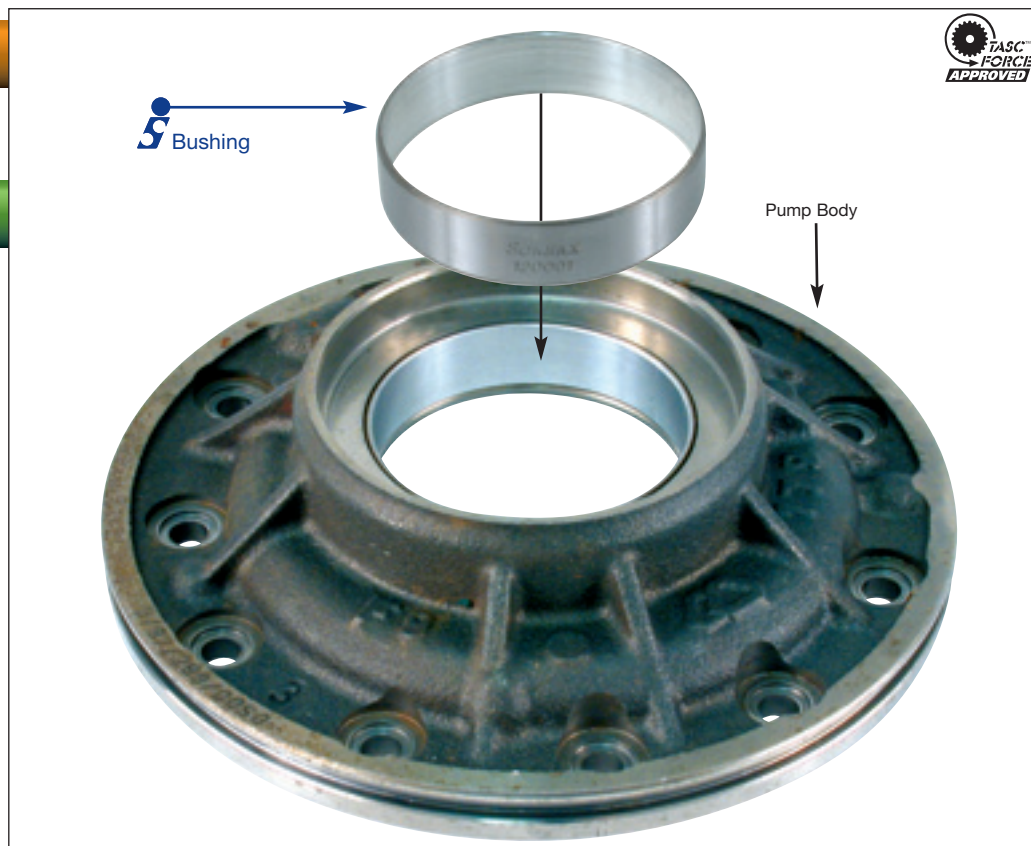
Front seal leakage, delayed engagement, converter shudder and slip

- Low pump volume

Excessive converter hub-to-bushing clearance.

DPO pump bushings are prone to wear due to poor tolerancing and material quality. Sonnax has developed both a direct replacement and a finish-in-place bushing.

Replace worn pump bushing with our precision bushing or finish-in-place bushing.

- Both bushings are steel-backed with an aluminum alloy bearing surface to provide greater wear resistance.
- Precision bushing **120001** requires no machining and restores the clearance required for proper operation.
- Bushing **120001A** has a greater wall thickness to allow rebuilders to finish to their own specifications.
