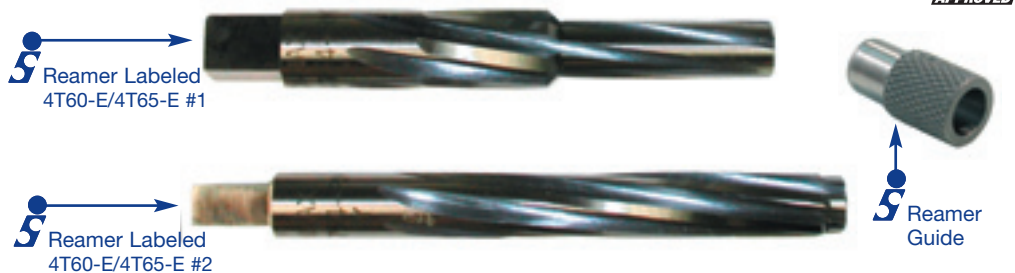
Tool Kit for 84754-40K

Delayed engagements, flared 1-2 shift

- Low reverse pressure • Burned 1-2 band

These complaints may be caused by the continuous reciprocation of the 1-2 (Forward) and Reverse servo boost valves wearing the valve body bores.

This oversized, anodized aluminum valve restores the hydraulic integrity, and has increased valve-to-bore contact to prevent leakage. This valve requires the use of a Sonnax reaming tool kit.

4T60-E and 4T65-E applications use 84754-TL2
