A Clutch Call

What 740/1740 codes can reveal about Chrysler converter flow

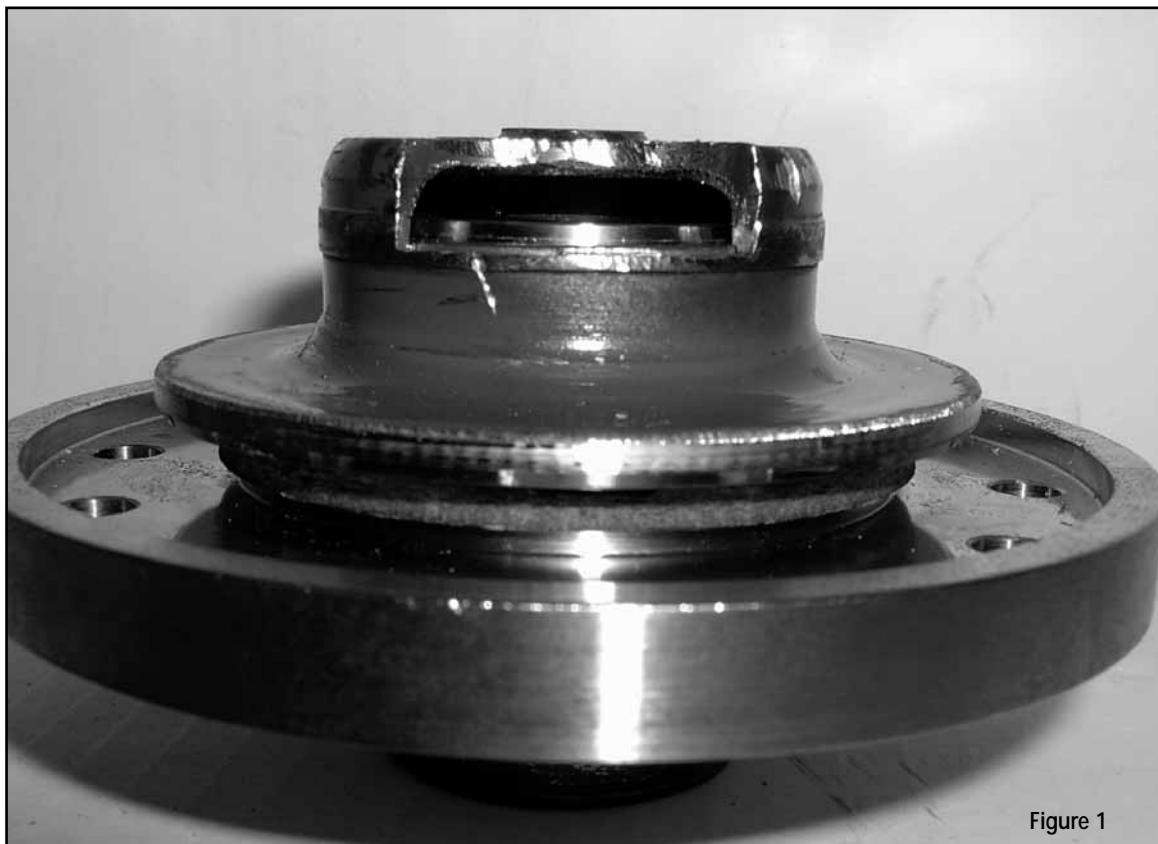
Figure 1

When the input (turbine) shaft is in its proper position in relation to the inside of the pilot (cover), it will look like the cut-away in *Figure 1*. The input shaft is about .125" away from the cover when the converter is installed to its proper depth. The proper way to check converter-to-flex-plate clearance is to push the converter back until the hub bottoms in the pump, then measure the distance between the flex plate and the converter pad. This measurement needs to be a minimum of .125", but no more than .250". The minimum of .125" is important to allow for a certain amount of converter expansion (ballooning), and to allow for a certain amount of movement by the flex plate. If the flex plate is bent, it could allow the converter to move rearward and restrict the flow of oil between the input shaft

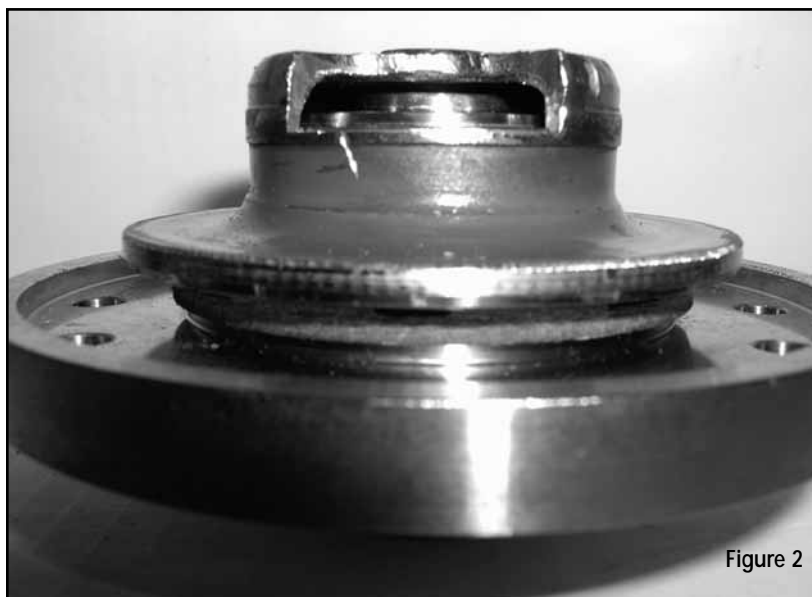
Figure 2

and cover. The example shown in *Figure 2* was close enough to cause a 740 code.

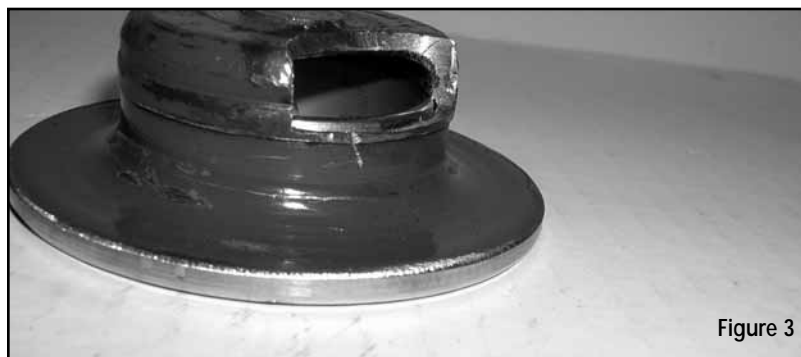
Figure 3

The turbine hub bushing is the next element that may cause a restriction. When the bushing is installed properly, the top of the bushing is flush to .020" up from the top of its bore. The bore for the bushing is in the pilot area of the cover and the top of the bushing bore is recessed about .028" below the thrust area for the turbine hub. The cut-away in *Figure 3* shows a bushing that was installed .080" (twice the thickness of a dime) below flush. You are viewing the bushing from the bottom side so you can see that flow was completely restricted. This, too, caused a 740 code.
