TORQUE CONVERTER PARTS

GM-WA-40 STATOR REPAIR PLATE

INSTALLATION INSTRUCTIONS

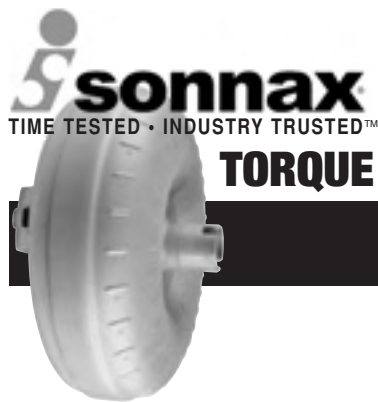
On late 4L80-E converters, the inner race sometimes produces excessive wear on the stator pilot. In some cases it wears completely through the stator, damaging the bearing back-up surface on both the stator and impeller hub side. Sonnax now offers a stator repair plate **GM-WA-40**. This repair requires machining out the damaged section, machining a precise hole for the plate, TIG welding the plate in place and machining the bearing back-up surface flat and to the correct depth on **GM-WA-40** (detailed instructions attached.) To repair a worn bearing back-up surface on the impeller hub side, use Sonnax's **GM-90-62G** flanged impeller hub.
