## Long slide shift into 2nd gear

## Oversized 1-2 Capacity Modulator Valve Kit

### 76991-01K

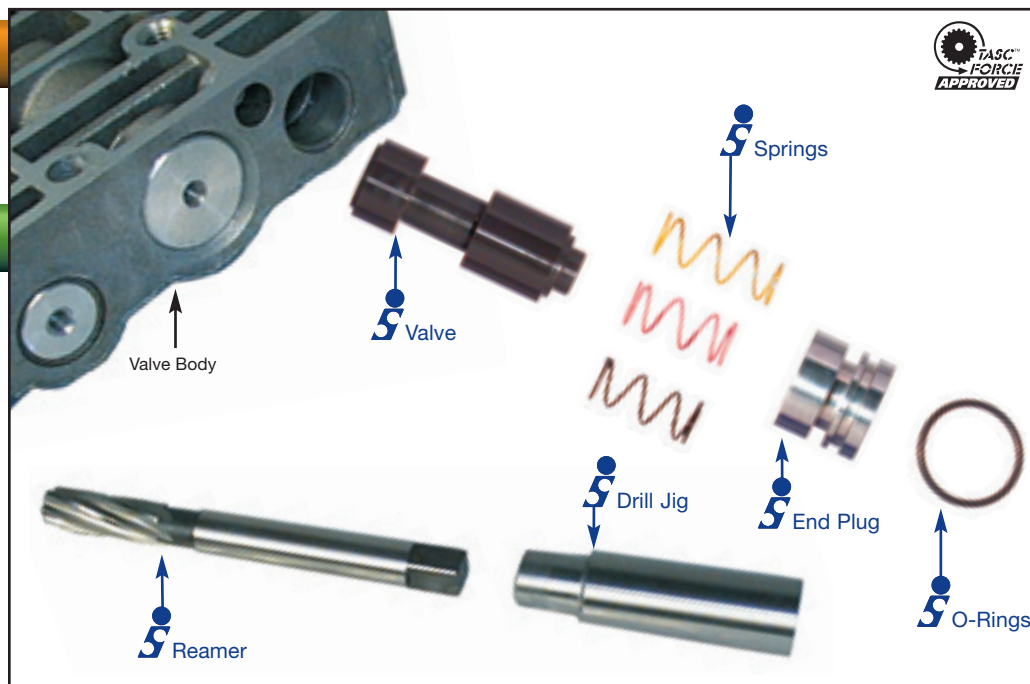
A worn 1-2 capacity modulator bore causes second clutch oil leaks and insufficient clutch apply pressure.

The AOD often has a long slide shift into second gear, intermediate clutch overhear, and/or direct clutch failure. In many instances the culprit is a worn 1-2 capacity modulator bore. The second clutch oil will leak past the outer balance spool and exhaust, creating insufficient clutch pressure. This can be seen on a gauge or valve body test machine as low 2nd clutch pressure that does not stabilize and fill completely until the road speed allows a shift to 3rd gear. This results in 2nd gear slide and burned intermediate or direct clutches. Sonnax now offers an oversized 1-2 capacity modulator valve **76991-01K** that restores the hydraulic integrity of the circuit.

This oversized 1-2 capacity modulator valve is made of hard-coat anodized aluminum to prevent wear, restore the hydraulic integrity of the circuit, and salvage the valve body.

- Valve is manufactured from hard-coat anodized aluminum to prevent bore wear.
- Kit includes an o-ringed end plug that prevents 2nd gear oil from exhausting through the bore.
- Three spring weights are included in the **76991-01K** kit to allow for more precise shift calibration.
