## Burned clutches and bands

## Accumulator Pin Kits

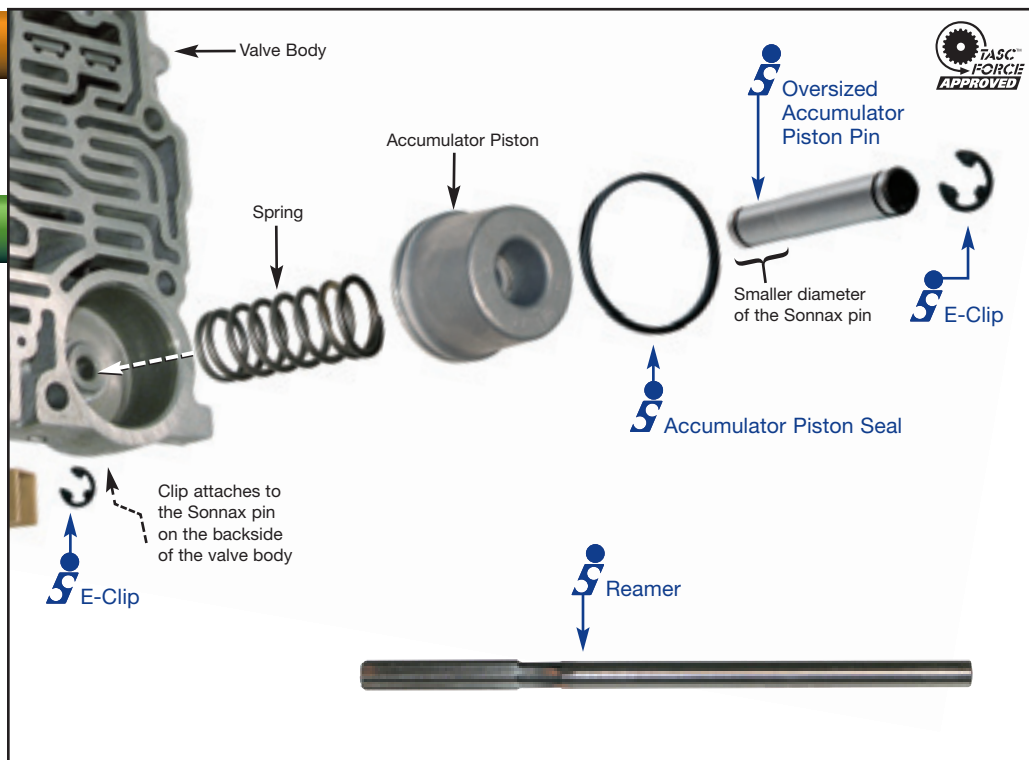
- Leakage at the accumulator pin bore

A worn accumulator pin bore and piston seal cause leakage at the accumulator piston.

The Sonnax oversized accumulator pin and Teflon® piston seal restores 1st-2nd accumulator circuit integrity.

**NOTE:** The early model TH180 has a removable e-clip retainer holding the accumulator piston and spring in place. The late model TH180 has a non-removable fixed head holding the accumulator piston and spring in place. The Sonnax pin will work with either of these applications.
