## Insufficient line rise or high reverse pressure

### Boost Valve Kits

### Sonnax Part Summary

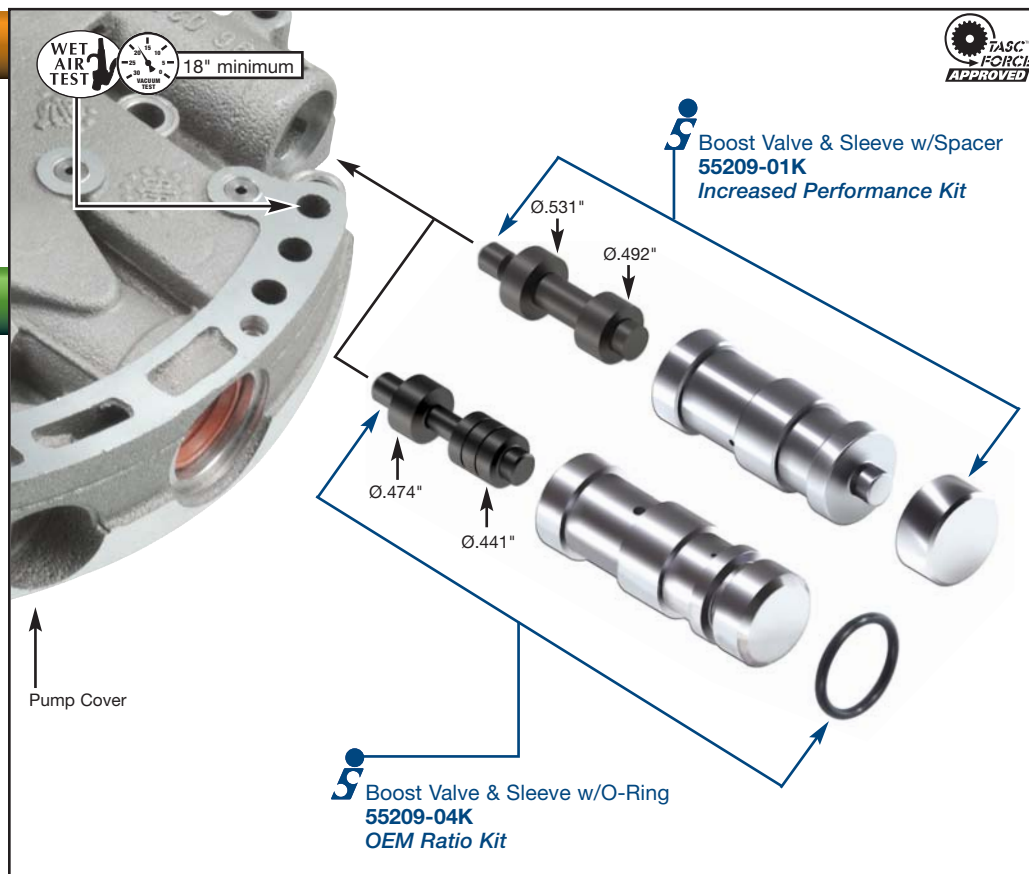
• Flare upshifts • TCC slippage or gear ratio codes

The boost sleeve increases line pressure for shift quality, engagement and proper TCC apply. As the sleeve wears, torque signal oil will leak to exhaust and line pressure will not increase as commanded.

These Sonnax kits restore proper clearance with upgrade design and material to prevent EPC and reverse boost loss. Increased performance and OEM ratio kits are available.
