Boost Valve & Spacer Kit

55209-01K

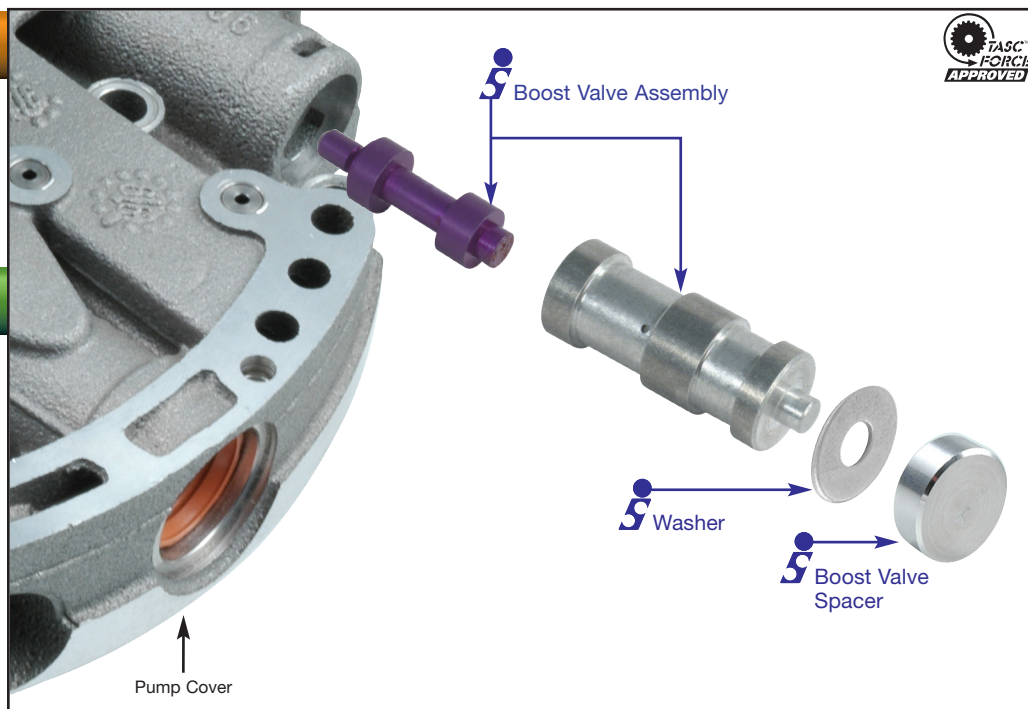
Insufficient line rise or high reverse pressure

- Flare upshifts • TCC slippage or gear ratio codes

The boost sleeve increases line pressure for shift quality, engagement and proper TCC apply. As the sleeve wears, torque signal oil will leak to exhaust and line pressure will not increase as commanded.

This Sonnax kit includes a spacer and .490" EPC ratio boost assembly, which prevents loss of EPC and reverse boost to restore correct line rise.
