## Upgraded Front Sun Gear Shell Bushing

96009-01

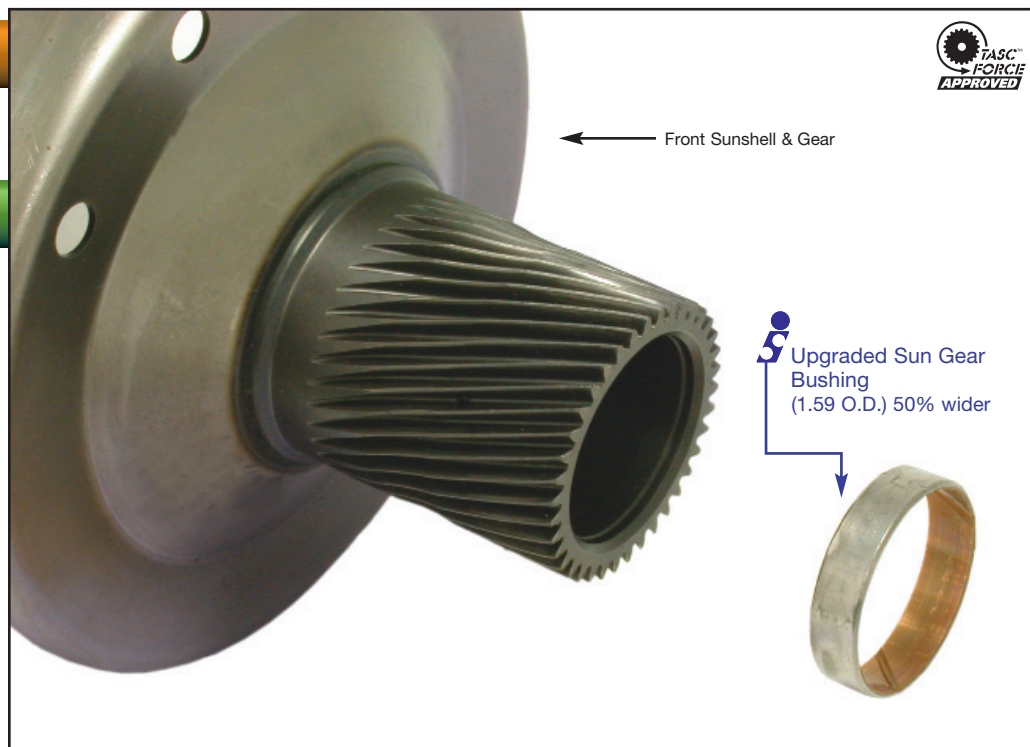
Lower sun gear shell bushings wear prematurely

- Loss of lube oil

OEM and aftermarket bushings are too narrow for application.

In vehicles with AXOD & E ('88-'92) transmissions it is common for the lower sun gear bushing to wear. The sun gear holds two bushings, an upper and lower bushing. The upgraded Sonnax bushing **96009-01** replaces the lower and upper sun gear bushings.

This wider bushing gives more support and reduces shaft-to-bushing clearance.

- The Sonnax bushing is 50% wider for better support.
- Bushing has less bushing-to-shaft clearance than other available bushings.
