## COMPLAINT

## Throttle Valve Sleeve Kits

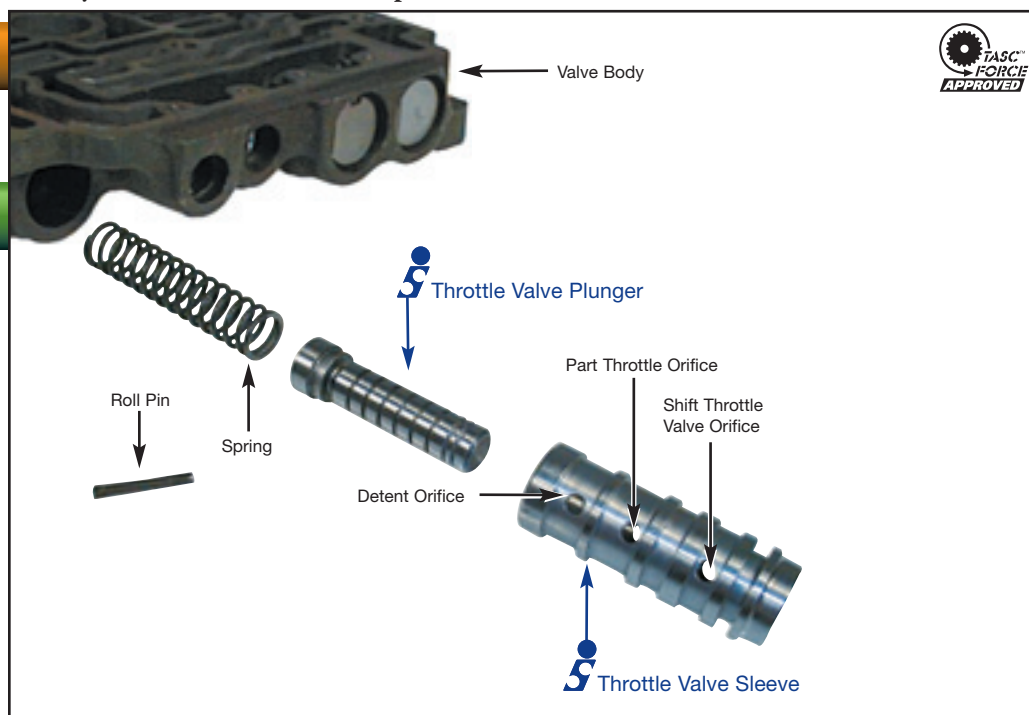
Wear at the internal sleeve diameter allows TV and detent oil to exhaust.

Poor line rise, no detent downshifts, and soft 1-2 shifts are common complaints in vehicles with a THM 200 transmission. The steel throttle valve plunger continuously reciprocates within the steel throttle valve plunger sleeve, wearing the sleeve. This wear allows shift TV oil to leak past the plunger and exhaust, resulting in poor line rise. Also, detent feed oil leaks past the plunger and results in poor shift timing and/or soft shifts. This excessive leakage can be eliminated by installing one of three Sonnax replacement throttle valve plunger and sleeve kits: **65754-01K**, **65754-02K** or **65754-03K**.

These valve and sleeve kits eliminate both shift TV oil leaks and detent feed oil leaks.

**Note:** These three kits have different sized plunger diameters that must be matched to the vehicle's TV valve. Identification grooves have been added for ease in matching with the OEM TV valve (see chart).
