COMPLAINT

Pump Gears

Sonnax Part Summary

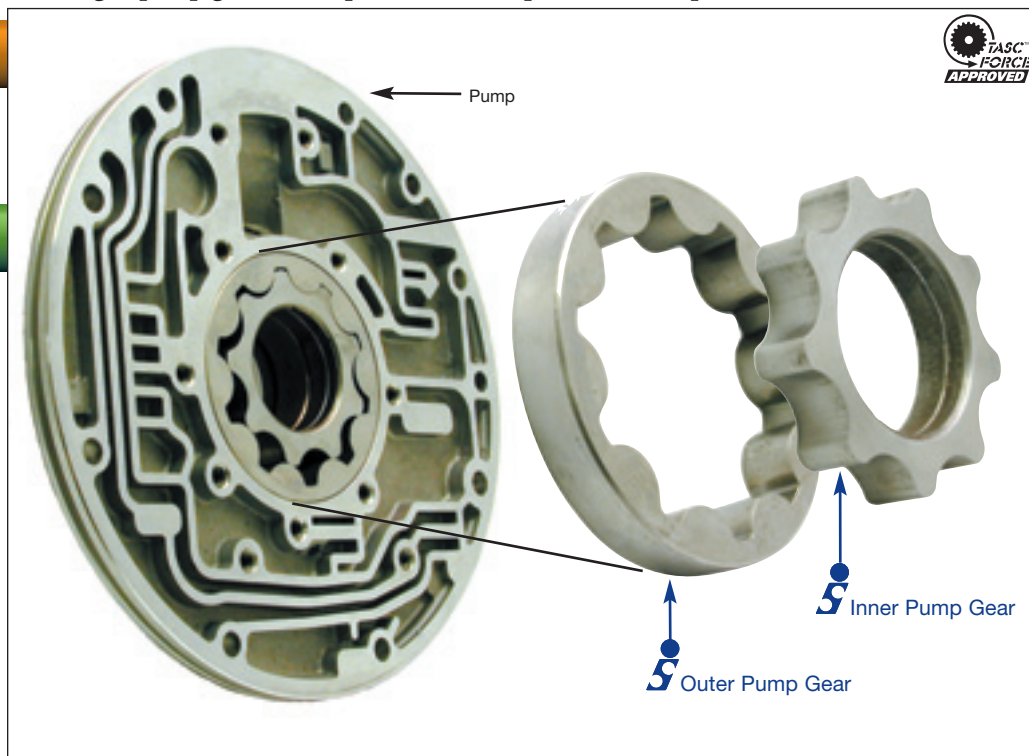
Low line pressure, excessive pump noise, code 62, 628, 1744

- Damaged pump gears or torque converter impeller hub • Repeated converter failure

Wear on the pump gears and with the mating impeller hub reduces pump capacity and increases pump noise.

These direct replacement and oversized gears are specially designed to improve the fit and durability of the pump-to-torque-converter interface.

- No machining is required for direct replacement **36438A**.
- Machining is required for oversized **36438AX-01K**. This kit is for F5 or later pumps only and cannot be used to update earlier pumps.
