## No forward, no 4th gear

## Forward Control Valve & Bore Sizing Tool

### 96206-07K

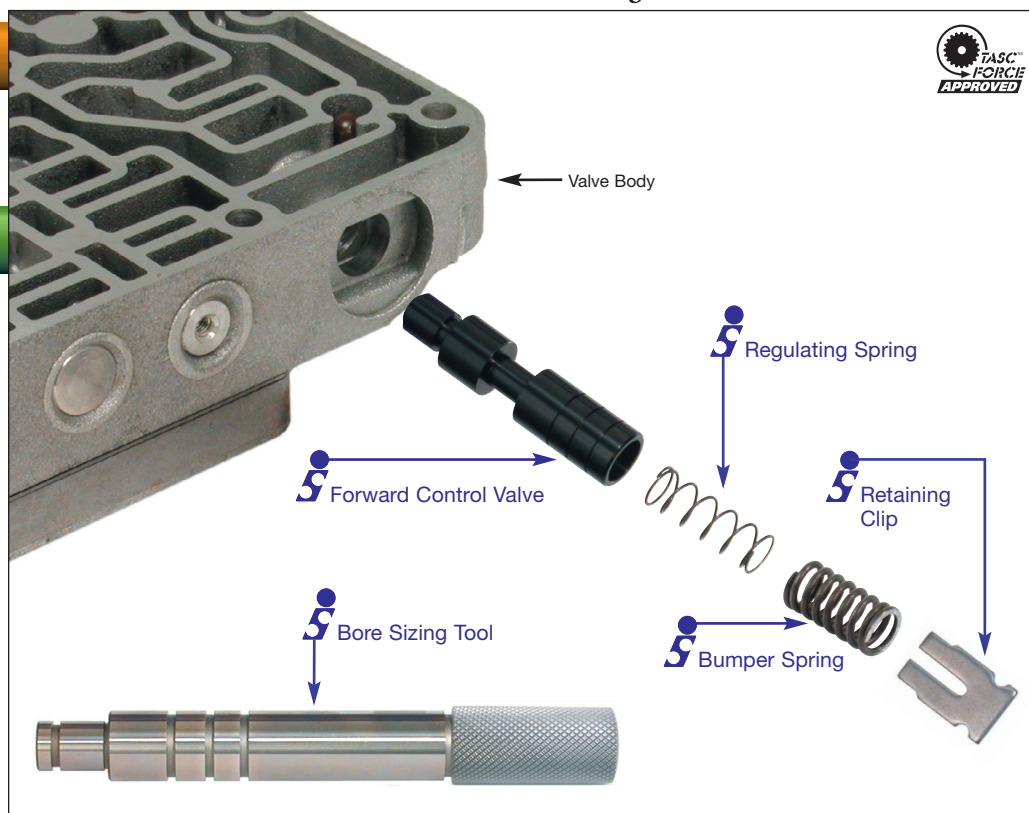
Forward control valve is bent or sticking from the stem, smashing into the retainer clip.

The front stem of the aluminum OEM forward control valve bangs against the steel retaining clip when stroked. The force of this constant banging often causes the valve to warp and seize in the bore, as well as breaking the OEM clip. No valve movement can result in a neutralling-out complaint, no 4th gear or a burned forward clutch. The Sonnax forward control valve **96206-07K** corrects these problems.

Resize the bore with this sizing tool and install the modified valve with multiple improved features.

**Note:** Although this valve does not require a reamer, use of the bore sizing tool is highly recommended.
