Accumulator Piston & Sleeve Kit

44892-03K

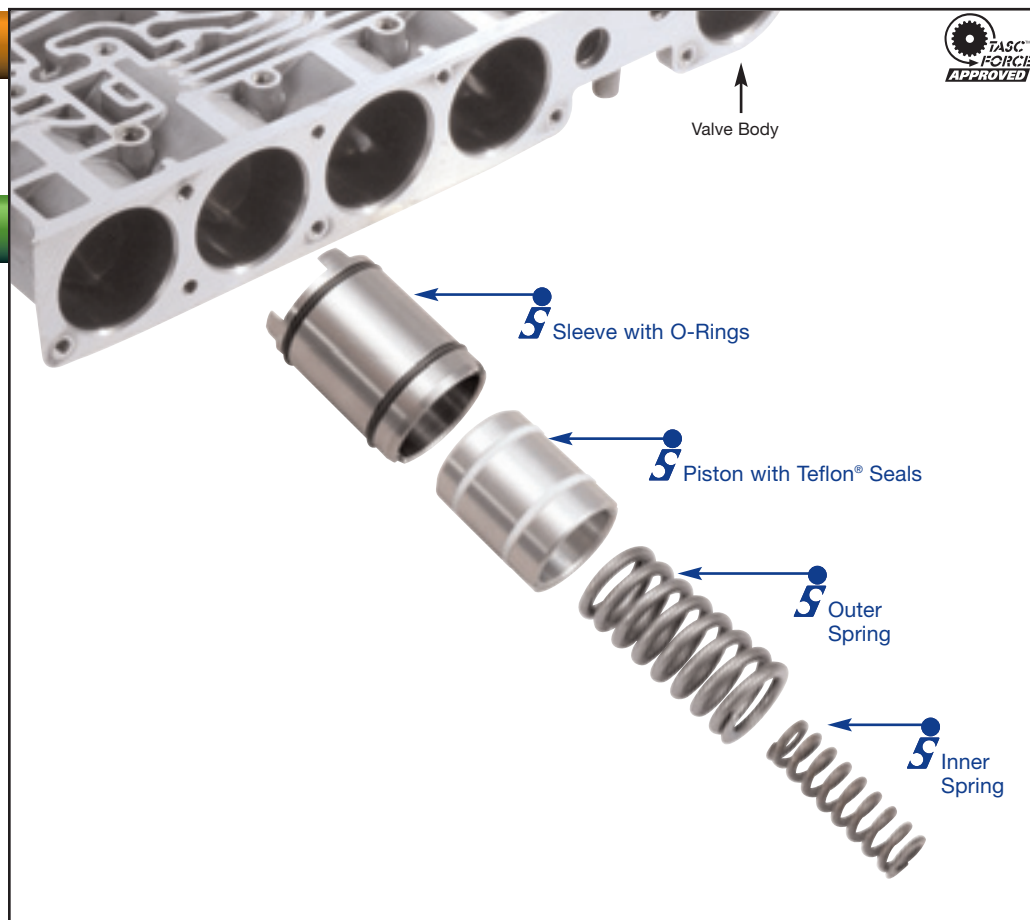
Scuffed and worn accumulator bores due to constant oscillation; damaged bores after accumulator plate breakage.

In a 45RFE or 545RFE transmission, the accumulator bores may become scuffed and worn due to the rubbing action of the Teflon® seals. The pistons may also damage the bores if the accumulator plate breaks, which is a common occurrence. These conditions create a poor seal, resulting in drivability complaints of shudder or slide shifts. Sonnax now offers a drop-in-place accumulator piston and sleeve kit that refurbishes worn or damaged bores.

This drop-in-place accumulator piston and sleeve kit refurbishes worn bores and saves valuable accumulator bodies.

Note: Fixes any of the five accumulator bores.
