Oversized Torque Signal Valve

84754-44

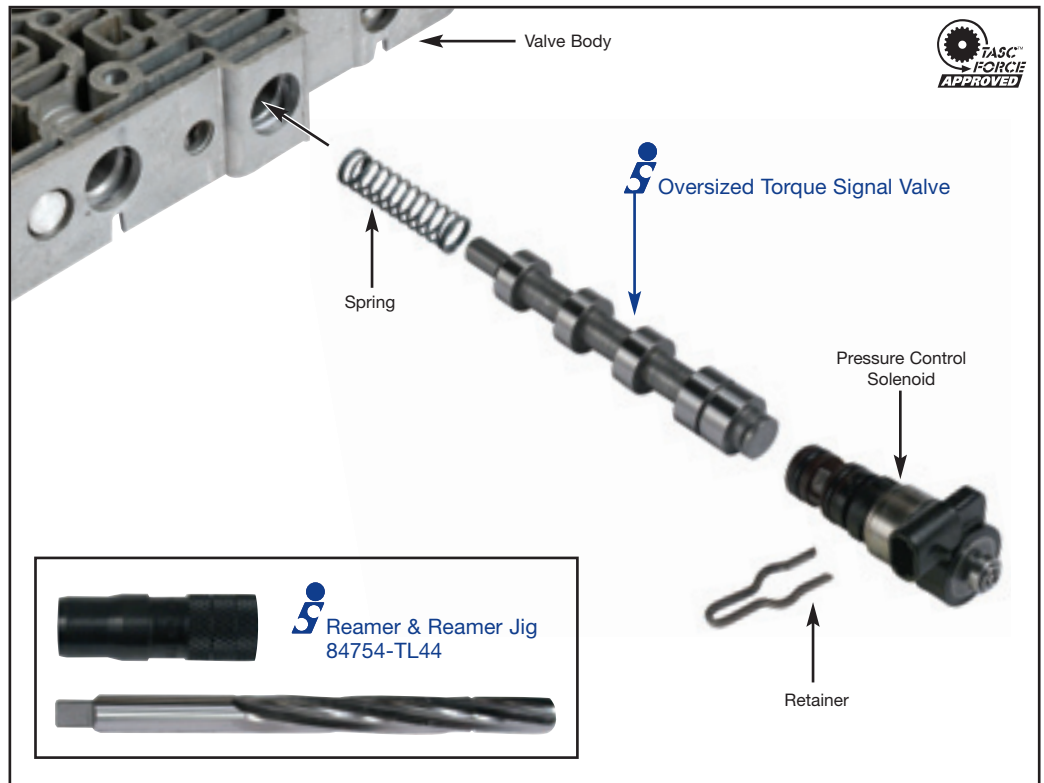
Note: To eliminate codes 1811 and 741 and TCC-related issues, be sure to also inspect the actuator feed limit valve, boost valve assembly, TCC regulated apply valve and TCC apply valve. The PCM must be reset/relearned after any valve body repairs. Aftermarket scanner relearn procedure or battery disconnect for 12 hours may not restore drivability and line pressure control. Performing a dealer reflash or a web reflash is frequently the only method to properly restore control.

Disassemble the valve body and discard the OEM torque signal valve only. Do not discard the OEM spring.

1. Lubricate the reamer jig, valve body bore and reamer with cutting fluid.
2. Insert the reamer jig in the solenoid bore. Begin the reaming process with the reamer marked **84754-RM44**.
3. Using a speed handle, ream the bore clockwise at 1 to 1 ½ turns per second. This reaming operation should take approximately two minutes.
4. Using low air pressure (35 psi) and with the reamer remaining in the bore, blow chips out of the bore.
5. While continuing to turn the reamer clockwise, remove it from the bore. Clean the remaining chips from the bore

1. After thoroughly cleaning the reamed valve body install the OEM spring into the bore.
2. Lubricate the new oversized valve with ATF and install it into the bore.
3. Install solenoid and retaining clip.
