1-2/4-5 Overlap Valve Kit

68942-19K

Sonnax Part Summary

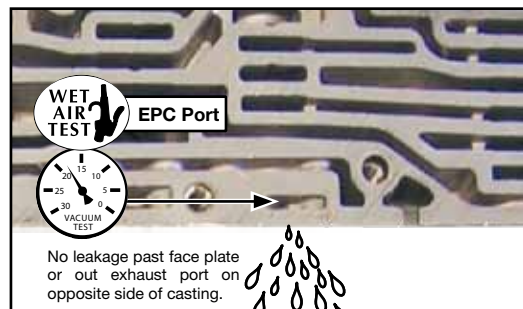
A Wet Air or Vacuum Test in the location shown, results in leakage. A Vacuum Test must hold a minimum of 18". If you cannot effectively perform a WAT or Vacuum test, visually inspect the inboard overlap bore.

The improved Sonnax overlap valve kit restores hydraulic sealing and valve timing when installed in a refurbished bore.
