Identify your I.D.

Your impeller hub affects your charge

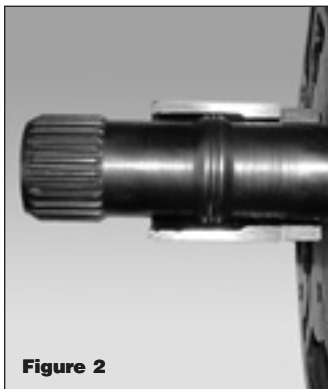
filter, a plugged vent or elevated line pressure are all examples. We all know what happens when a C3 modulator is mistakenly installed in an A4LD transmission. The elevated line pressure will keep the converter from filling. Another common mistake was to put a GM 400-style impeller hub on a TF8 converter: The smaller I.D. would restrict converter charge. On a non-lockup converter, charge oil passes between the stator support and the I.D. of the impeller hub to enter the converter. Restricting the clearance between the stator support and the impeller, as shown in Figure 1, will greatly reduce the converter's ability to fill. Figure 2 shows the proper stator support-to-hub clearance.

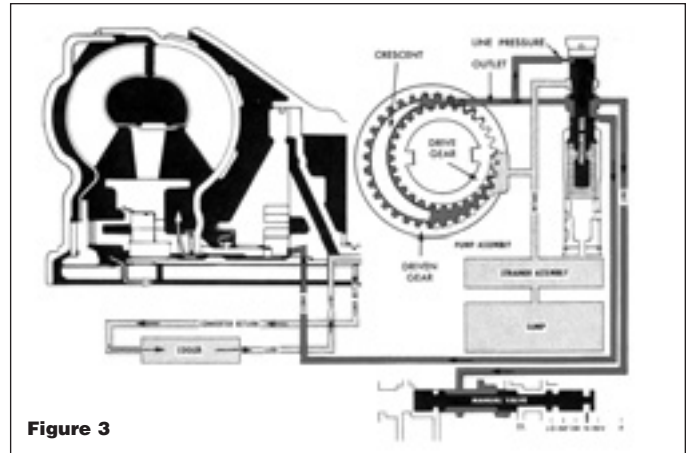
Figure 3

There is another very important way that the I.D. of the impeller hub affects converter charge. The raised area of the stator support creates an orifice with the I.D. of the impeller hub. This orifice lives just downstream of the pressure regulator valve on an oil chart. The oil entering and exiting the torque converter must maintain the proper charge pressure for maximum converter charge (see Figure 3).
