Endplay Shim Kit

42000-01K

Sonnax Part Summary

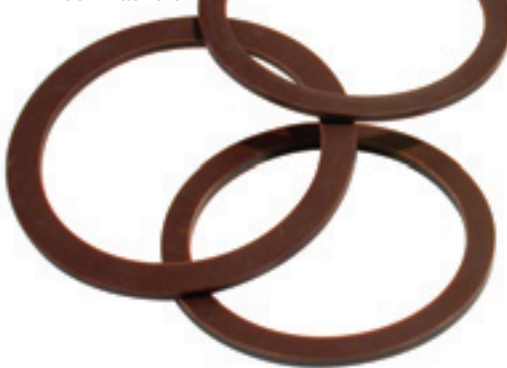
Flare 2-3 or 3-2 shift

- Endplay set-up shims unavailable • Delayed forward or reverse • Excessive endplay

Lack of a shim to lift the gear train allows for excessive clutch drum travel, while placing excessive shims between pump and drums reduces sealing ring contact and results in clutch circuit oil loss

This shim kit includes seven fiber washers for pump/drum set-up and six steel shims for supporting the rear/forward clutch drum.
