Bell Housing or Pump Cover Bushing

56001X

Sonnax Part Summary

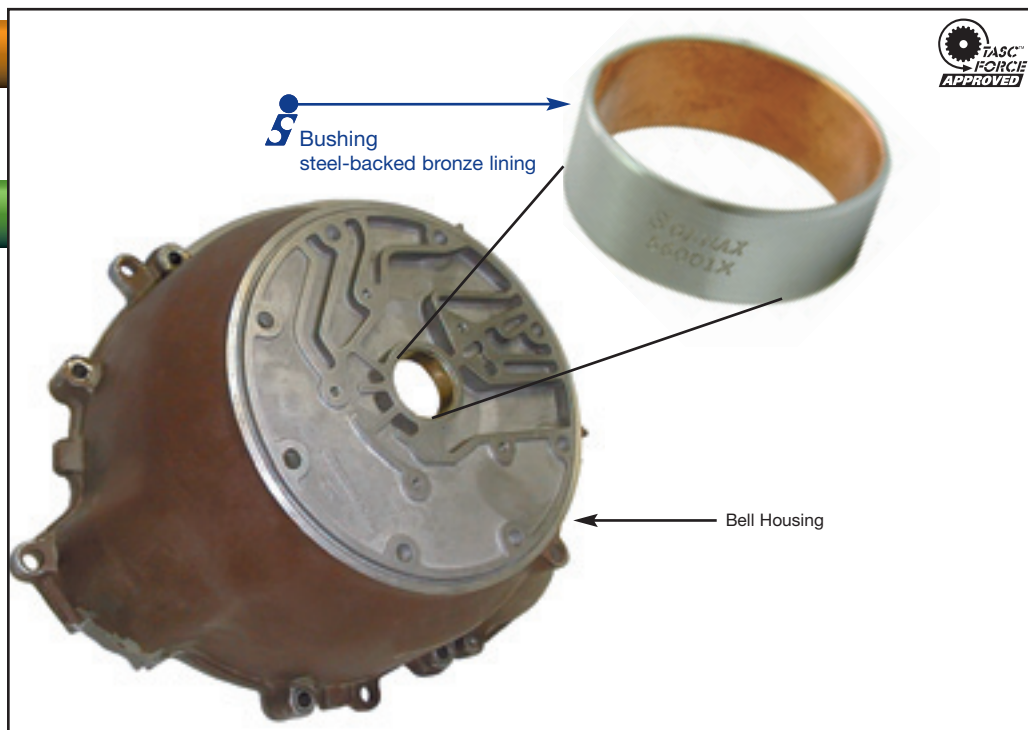
Repeated front seal leakage, worn pump bushing

- Worn converter hub

Excessive hub-to-bushing clearance and soft babbitt bushing material.

This finish-in-place bushing replicates the OEM bell housing or pump cover bushing assembly and has a steel-backed bronze lining.

Note: Finish-in-place style bushing requires advanced machining skills to ensure proper I.D. & location after installation.
