Sonnax Technical Bulletin

TAKE COMPLETE CONTROL

OF YOUR SLIPS, BUMPS, &
SHUDDERS WITH THESE
UNIQUE TCC CONTROL FIXES

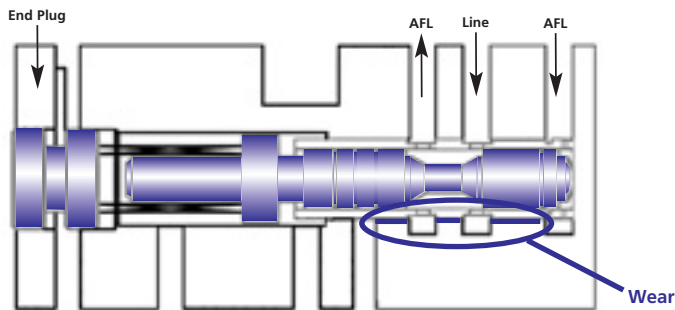
Figure 2

Actuator Feed Limit Valve

Pressure loss caused by wear results in reduced AFL signal available to PWM solenoid.

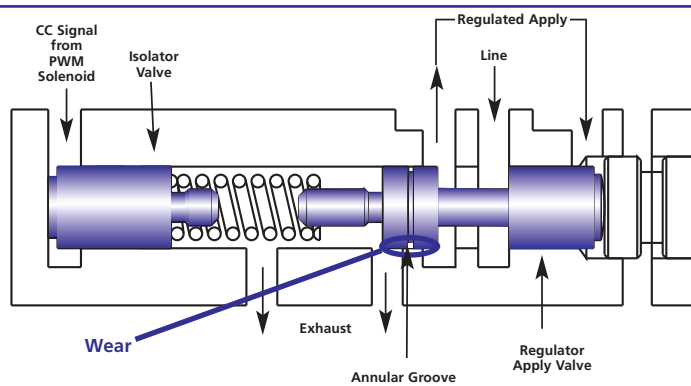
Figure 3

TCC Isolator & Regulator Valve

Pressure loss caused by wear results in a reduction of the intended regulated apply pressure.

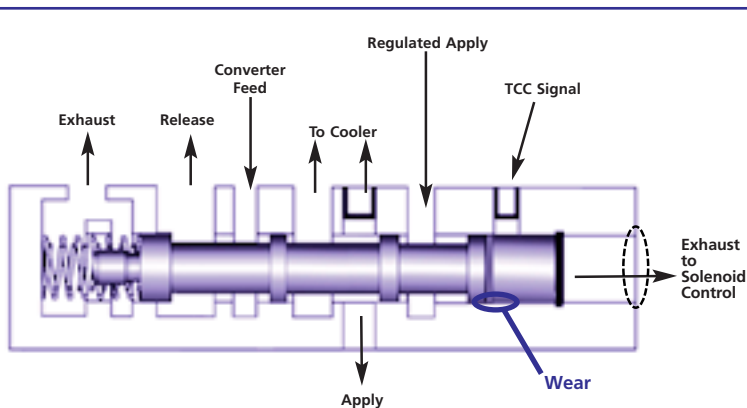
Figure 4

TCC Apply Valve

Pressure loss caused by wear prevents valve from stroking properly. Regulated apply pressure may be reduced or even prevented from being fed to the converter.
