Servo Band Strut

69700-01

Sonnax Part Summary

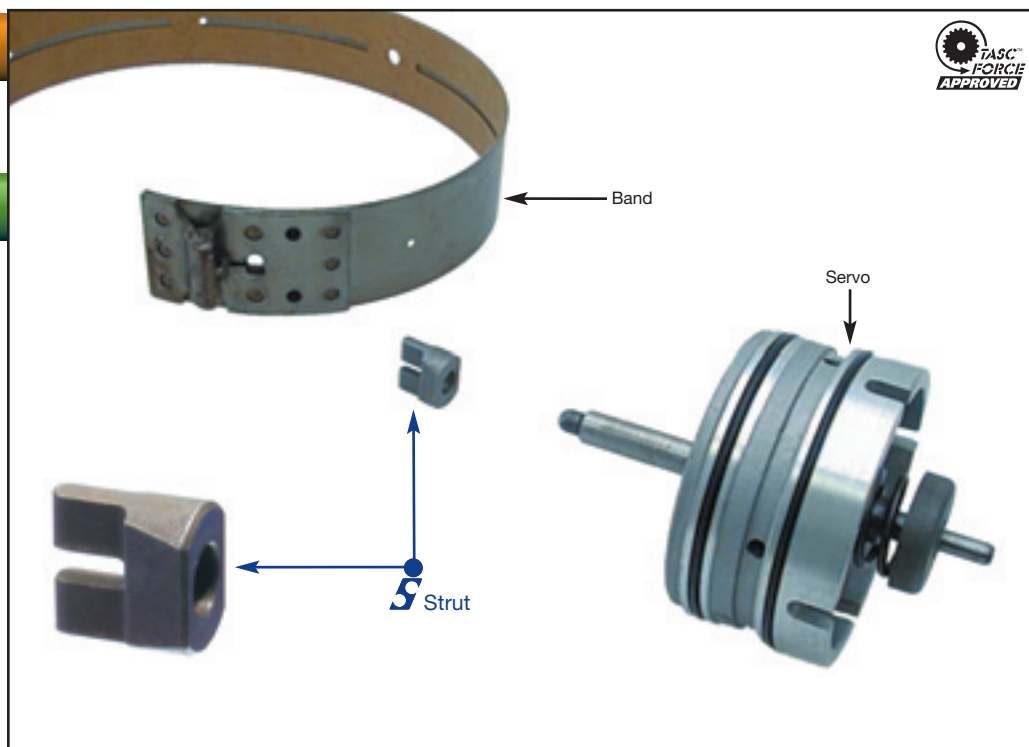
Loss of 2nd and 4th gear

The OEM strut splits in half under pressure from the servo piston.

In RE4R01A, RL4R01A, RE4RO3A, R4AX-EL and R4A-EL transmissions, the OEM strut has a tendency to split in half under pressure from the servo piston. This results in loss of 2nd and 4th gear.

This strut is made from higher quality material and has a wider cross section.
