Finish-In-Place Pump Bushing

36002-01

Sonnax Part Summary

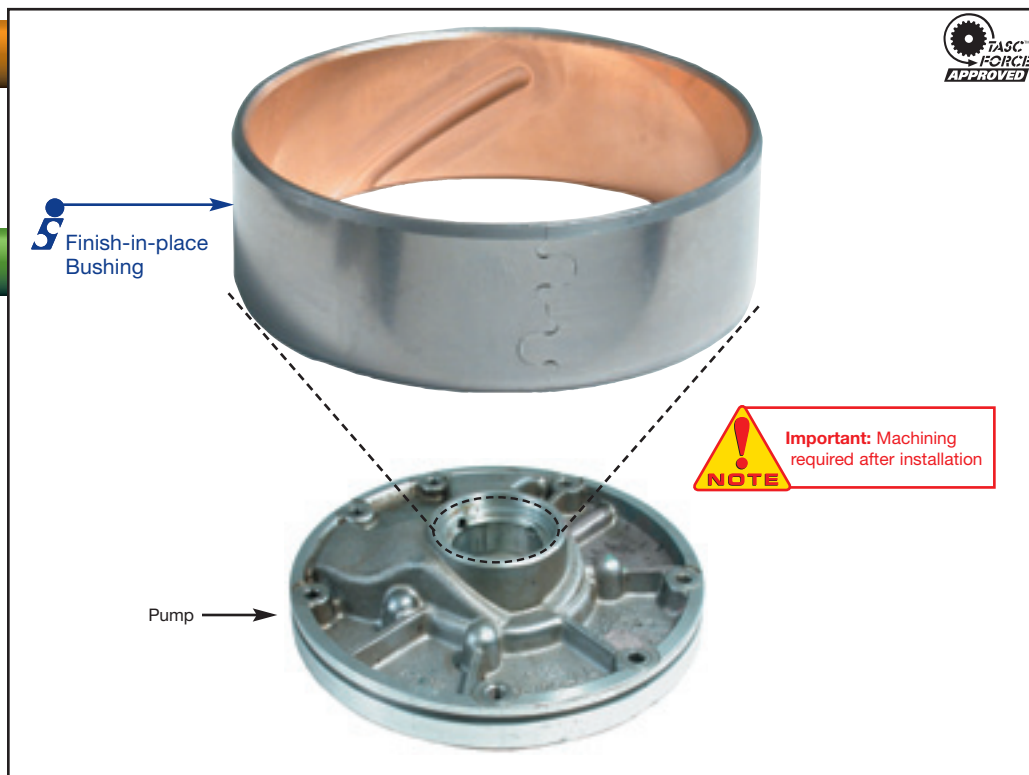
Front seal leakage, low pump output

- Excessive converter hub-to-bushing clearance • Pump noise

OE bushings are machined in place and drop-in replacement bushings are not thick enough, resulting in too much hub-to-bushing clearance.

This finish-in-place bushing replicates the OEM pump bushing and has a steel-backed bronze lining.

- Bushing is steel-backed bronze for better wear resistance.
- When installed, bushing allows .008" to .010" material removal for maintaining correct bushing-to-hub clearance.
