Oversized Throttle Valve Plunger & Reamer

Sonnax Part Summary

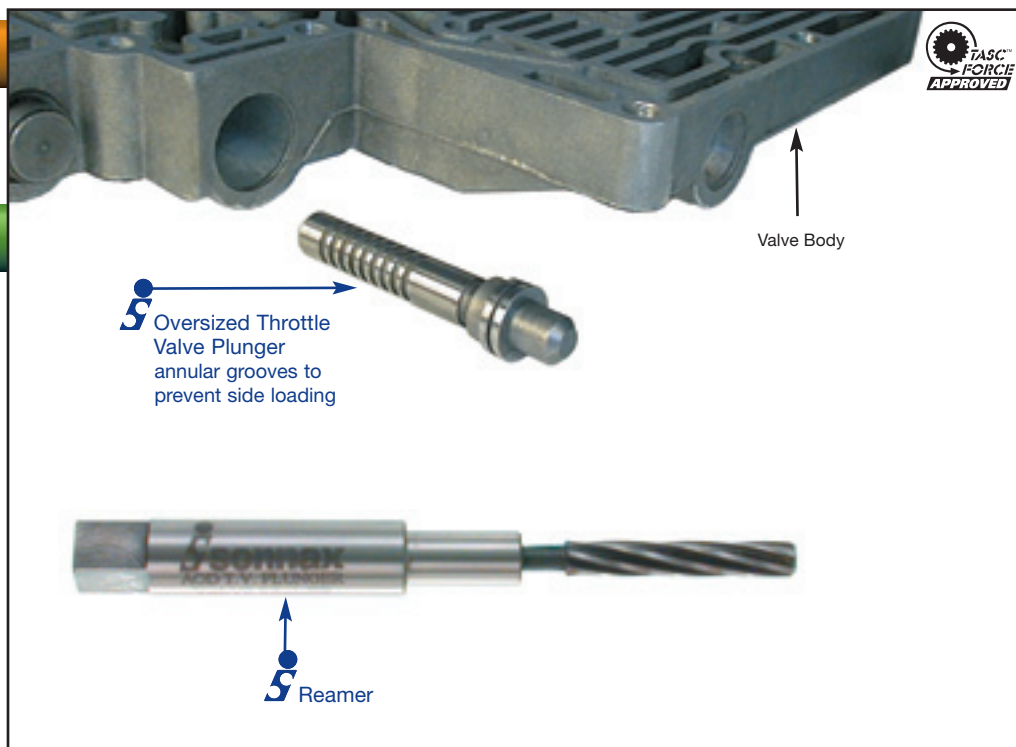
Poor line rise, sticking plunger

- Uncontrollable throttle pressure

Valve body wear allows throttle valve feed oil to leak past the plunger and exhaust, resulting in poor line rise.

Oversized TV plunger restores hydraulic integrity.
