# New options for rebuilding the E4OD/4R100/5R110W Converters

by Mike Morin

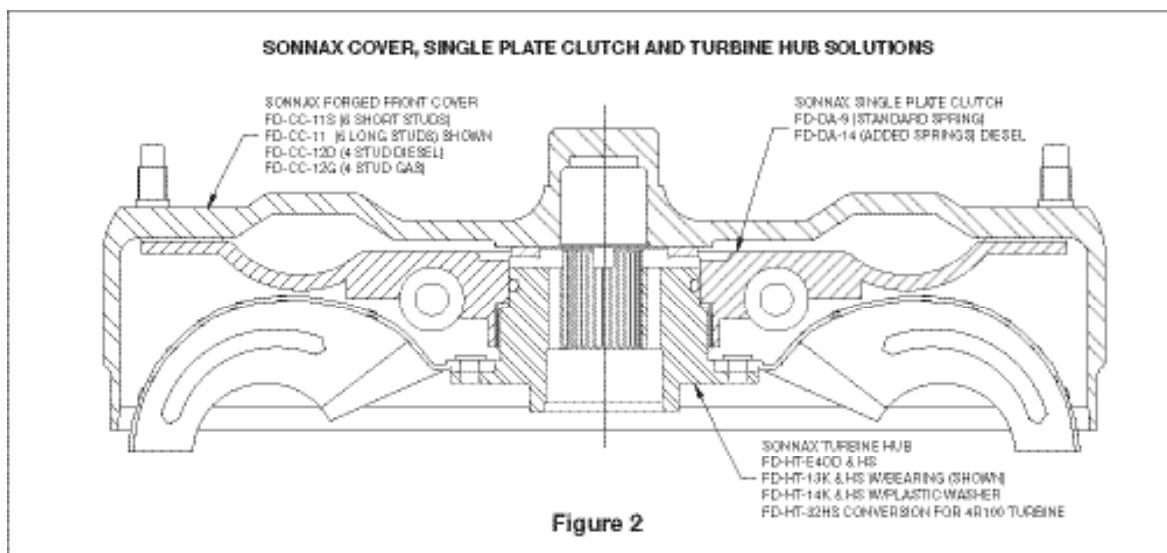
Figure 2

This multi-plate clutch is not available and, to make matters worse, the E4OD turbine isn't compatible with the new turbine hub and 4R100 multi-plate clutch. The only rebuild option was to change this converter to the single friction piston damper with stiffer springs (*see Figure 2*). However, this is not always the preferred method because clutch torque capacity is reduced by using only a single friction clutch.

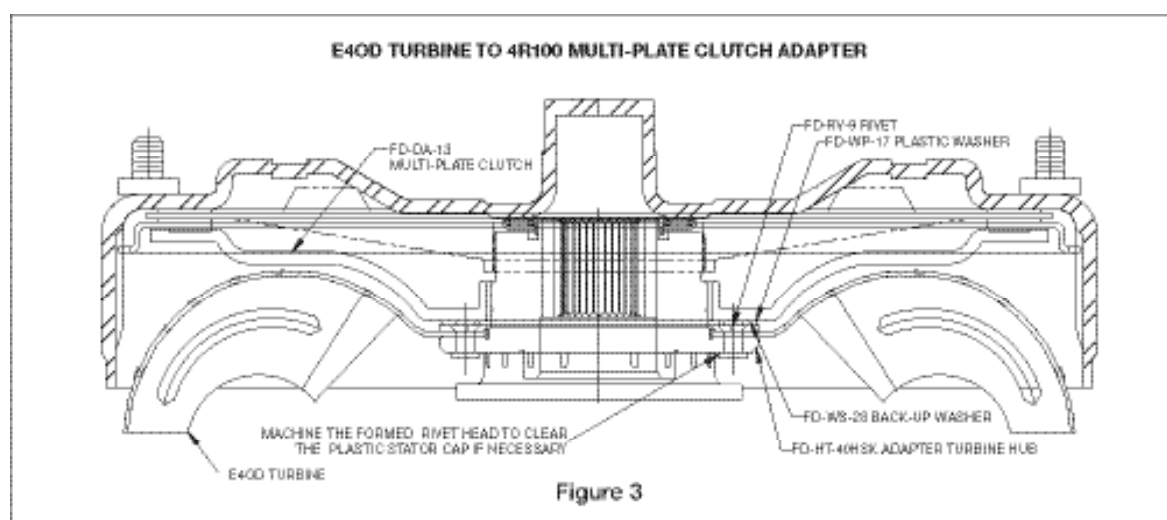
Figure 3

There are now two new ways to repair this converter. First, the Sonnax FD-HT-40HSK kit will adapt the E4OD turbine to the later 4R100 multi-plate clutch design by means of a special turbine hub, reinforcement ring and associated rivets. This kit is used with the 4R100 multi-plate clutch assembly, FD-DA-13 (*see Figure 3*).

Around 1999 the splines on the O.D. of the piston were removed and the seal ring was replaced with a bushing on the I.D. A third friction disk was added to a splined ring, making the assembly three pieces (see Figure 3). The tight fit between the piston bushing and the turbine hub greatly reduces excessive movement of the piston and provides a seal. This design is currently used on late 4R100 and current 5R110W converters.

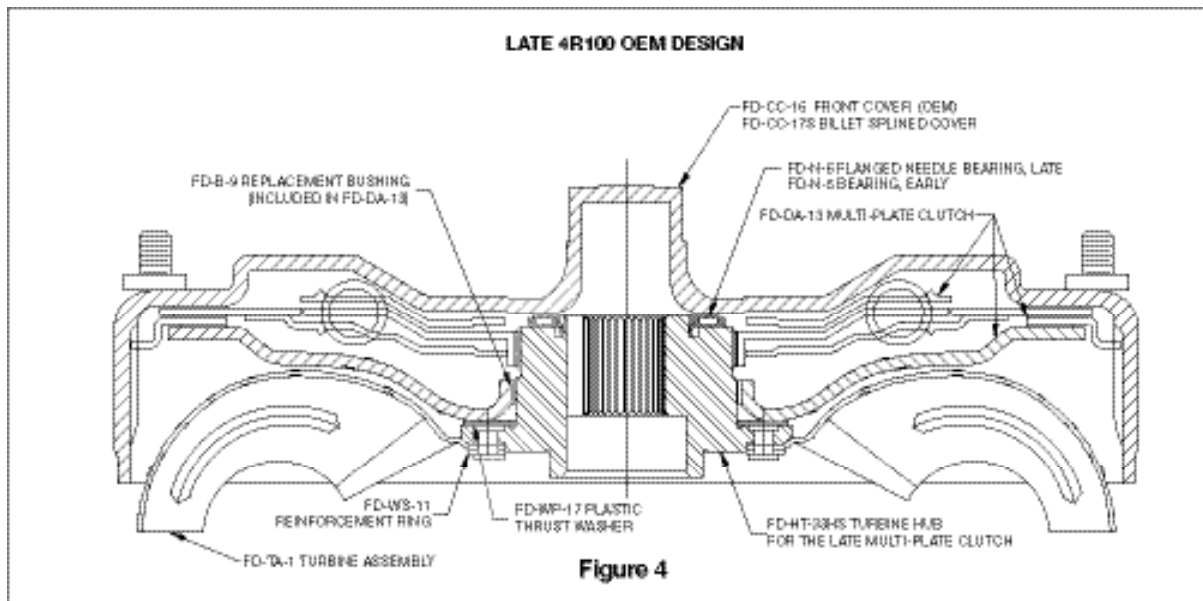
Figure 4

The second method is to replace the E4OD turbine with the Sonnax 4R100 turbine FD-TA-1. This requires using the Sonnax turbine hub FD-HT-33HS along with the multi-plate clutch assembly FD-DA-13 (*see Figure 4*). This upgrade will make your E4OD converter identical to the late 4R100 design.

This assembly can be fixed in two ways: Use the late OEM multi-plate clutch design with Sonnax turbine hub FD-HT-33HS (see Figure 4) or if the clutch assembly is damaged, the FD-HT-32HS turbine hub can be used to convert to a single clutch unit (see Figure 2).

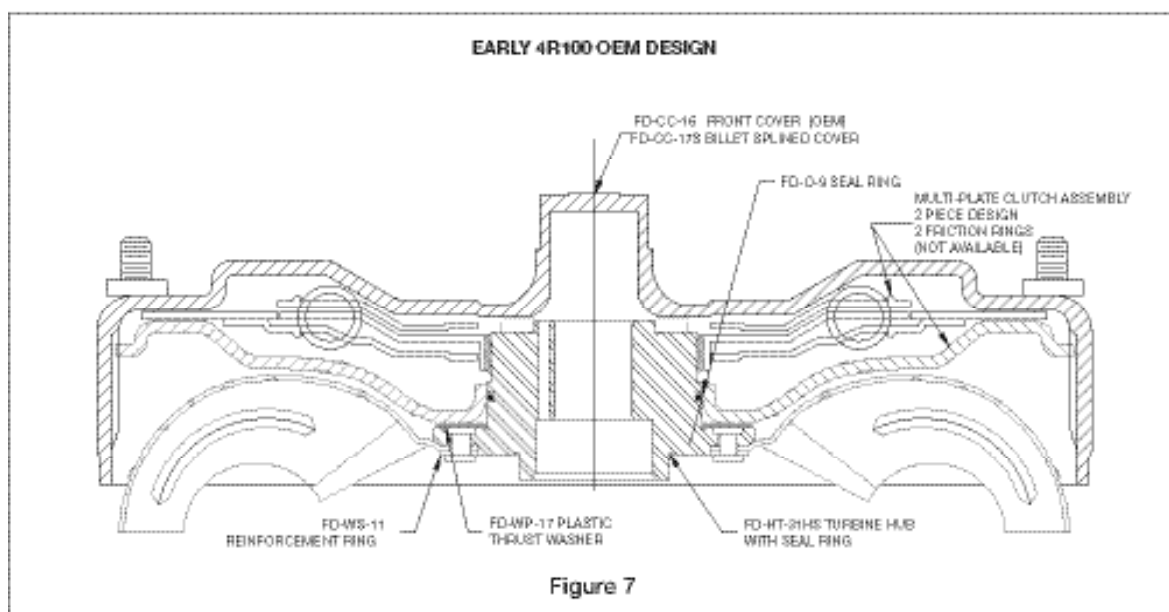
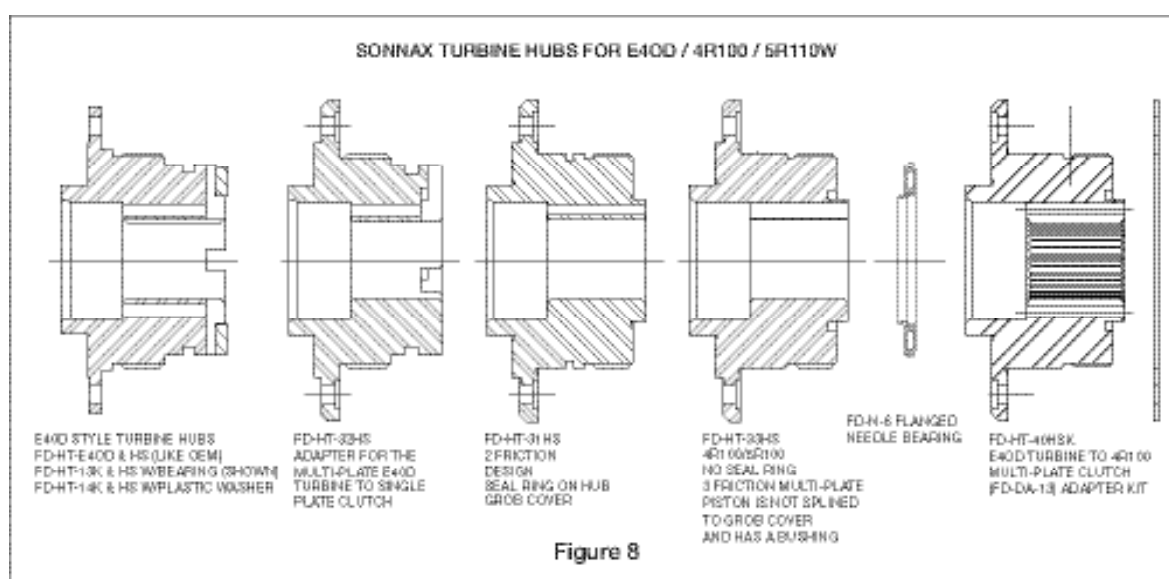
Around 1998-99 the piston was designed with splines on the O.D. and a seal ring on the I.D. This design didn't work well because the piston was allowed to move around too much in the converter. This eventually caused severe wear on the splined O.D. of the piston, which caused it to rattle. Ford sent out a tech bulletin to replace these converters because of the excessive clearance. This is a two-piece multi-plate assembly. (See Figure 7).
