Planetary failure, shaft breakage

## Overdrive Clutch Hub Bushing

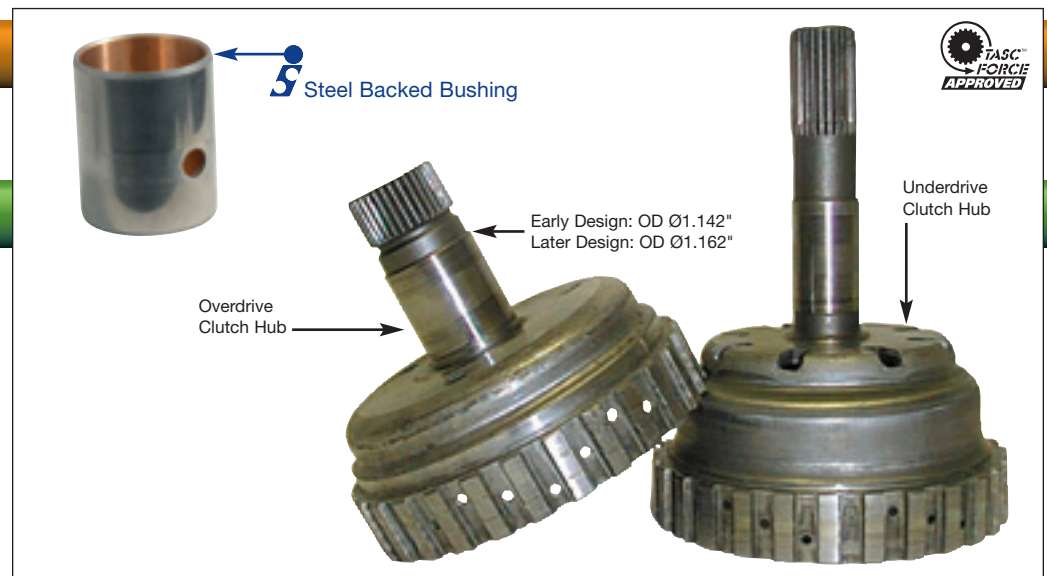
Poor tolerancing of the OEM bushings allows critical lube to exhaust.

The OEM overdrive clutch hub bushings in 41TE and 42LE units are poorly toleranced and allow leakage that can lead to lube exhaust and planetary damage. The Sonnax replacement bushings **92004-L**, **92004-LOS** and **92004-SP** replace the two-piece OEM bushing and provide a more closely toleranced fit.

These unique replacement bushings restore the desired fit with the underdrive shaft to prevent excessive radial movement.

**92004-LOS** is for the later design (1996 & up) 41TE, 42LE  
Housing Dia. .9410

**92004-L** is for the later design (1996 & up) 41TE, 42LE  
Housing Dia. .9370

**92004-SP** is for the early design (1995 & earlier) 41TE  
Housing Dia. .9590
