Oversized Manual Valve

15741-41

The Sonnax oversized manual valve **15741-41** addresses problems in Aisin AW TF-60SN units with delayed drive/reverse engagement, reduced line pressure and loss of valve body cores caused by excessive oil leakage due to wear in the manual valve and/or bore. Sonnax tool kit **F-15741-TL41** and **VB-FIX** are required to properly oversize the bore prior to installing the new manual valve.

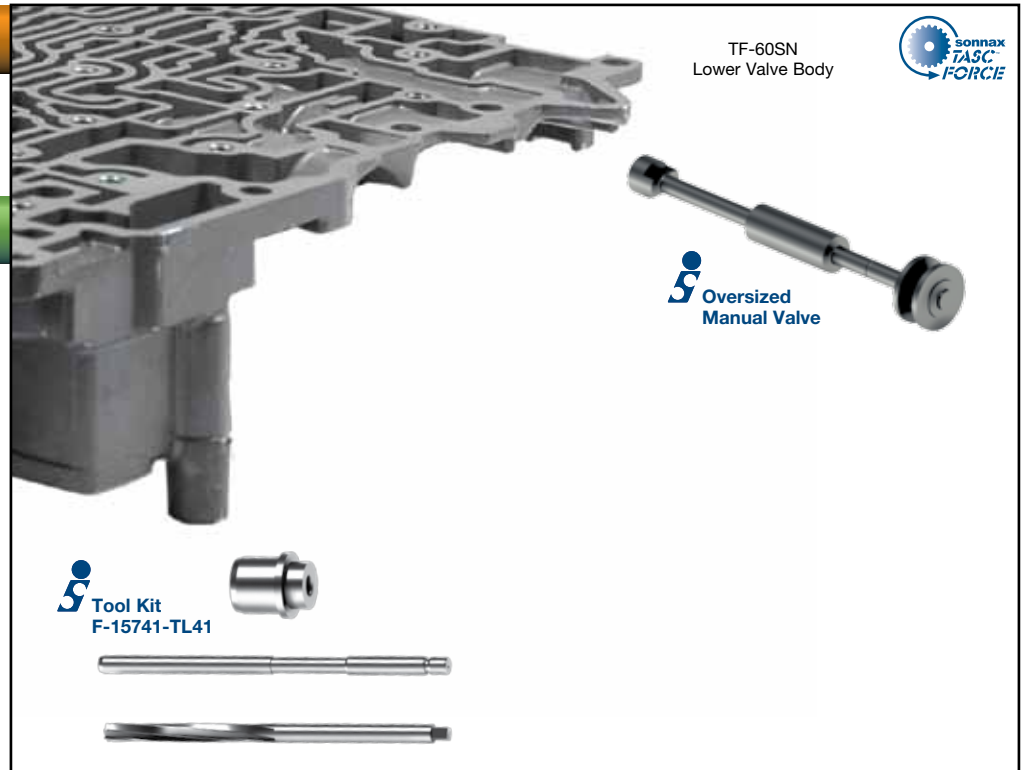
Reduced line pressure, delayed engagement

- Loss of valve body core

Manual valve and/or bore wear due to linkage side loads and/or extended service life.

Ream the bore and install the Sonnax oversized manual valve.

NOTE: Sonnax "F-Tool" kits designed to service a specific bore require the VB-FIX, a self-aligning valve body reaming fixture. More information and instructions are available at www.sonnax.com.

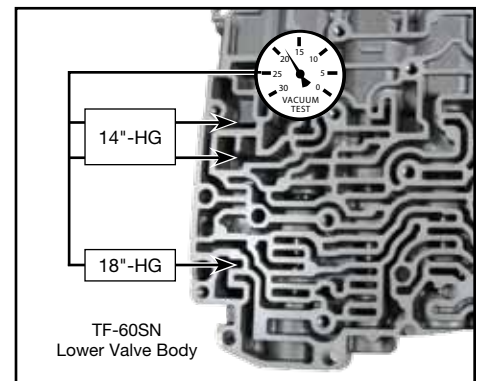
A vacuum test at either port indicated fails to hold 18" or 14" of vacuum or higher or if visual wear is detected at the inboard overlap valve bores.
