Late Model Low Sprag Update

56600B-01K

Sonnax Part Summary

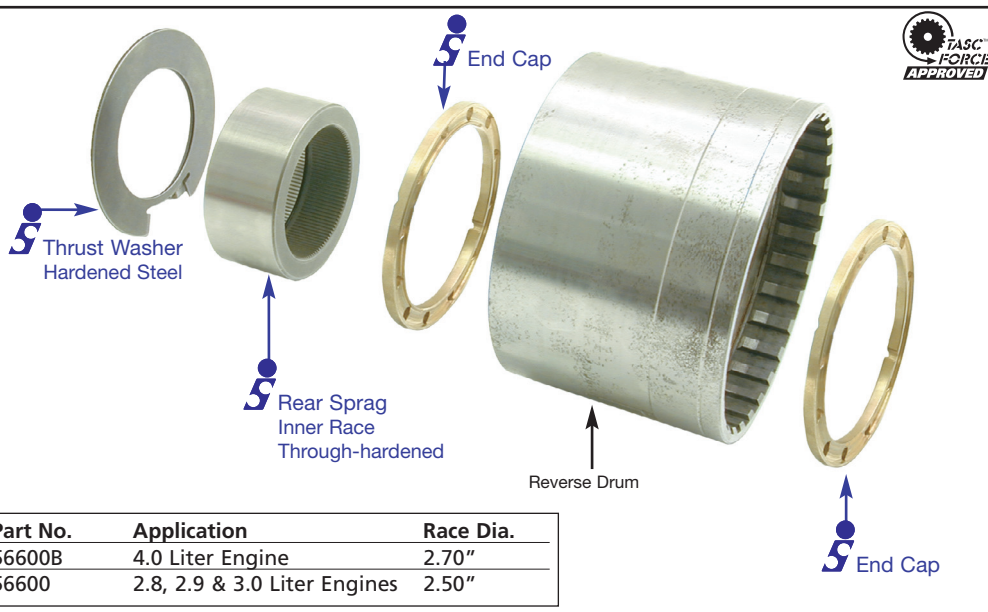
Sticking governor, bronze in the pan

The steel wave thrust washer and bronze "scoop" washers flex and contaminate the unit with metal.

A sticking governor after rear sprag service or sprag thrust washer failure is a common complaint in late model A4LD 4.0L units. This is caused by the steel wave thrust washer (located behind the rear sprag inner race) and the bronze "scoop" washers flexing and contaminating the unit with metal. During fabrication of the bronze washer, small cracks are formed between the bronze and steel layer of the washer. Once in service, these cracks allow bronze particles to flake off from the washer, and the problem is compounded by the flimsy steel thrust washer that it is running against. Sonnax now offers an A4LD Late Model Low Sprag Update Kit **56600B-01K** that allows A4LD 4.0 cases with worn or loose sprag races to be salvaged.

This kit salvages cases, prevents future metal contamination from worn washers, and has an upgraded inner race.

- Kit contains a new inner race of through-hardened AISI 52100 steel with longer, deeper cutting serrations to ensure a tight fit after reinstallation.
- A sturdy hardened steel thrust washer and two bronze end caps are included and are also available separately for use with 4.0 cases.
- Also available is Sonnax **56600**, a replacement race for the 2.8, 2.9 and 3.0 roller clutch units. This race is also through-hardened AISI 52100 steel with longer, deeper cutting serrations.
- The Sonnax drill jig **56600-DJ** allows for easy disassembly and installation of the inner race and eliminates the risk of damaging the case.
