Accumulator Piston Kit

15741-14K

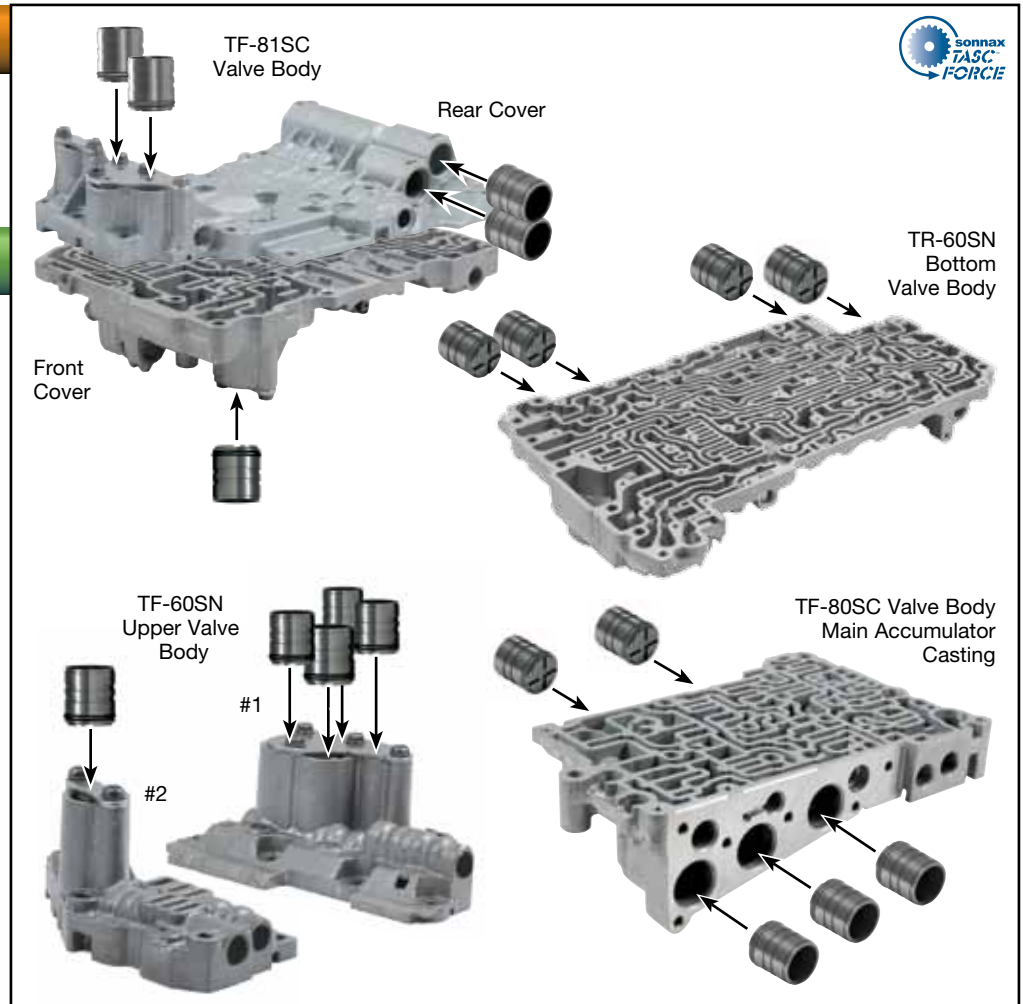
Wear at the cast aluminum accumulator bores by the steel pistons allows apply oil to exhaust.

Wear at the multiple accumulator bores on TF-80/81SC, TF-60SN and TR-60SN units is very common. At the clutch and band locations, wear allows component apply oil to exhaust, resulting in delayed engagements, slipping shifts, and burnt clutches and bands. Wear at the line pressure accumulator allows throttle signal oil leakage, which can result in reduced line pressure.

The Sonnax accumulator piston incorporates an O-ring for positive sealing and annular grooves for better centering and wear prevention.

The Sonnax accumulator piston kit **15741-14K** incorporates an O-ring for positive sealing and annular grooves for better centering and wear prevention. This kit fits in several locations throughout the valve bodies as shown above.

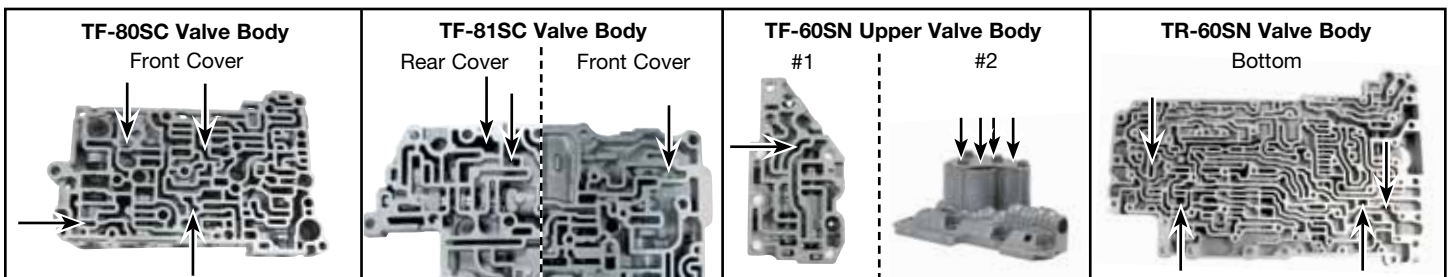
Visual inspection of the bore often shows shiny patches of wear. If wear is visible, perform a wet air or vacuum test in the necessary locations as shown. Vacuum test must hold a minimum of 18".
