## 1-2 Capacity Modulator Bore Sizing Tool

**96201-BST3**

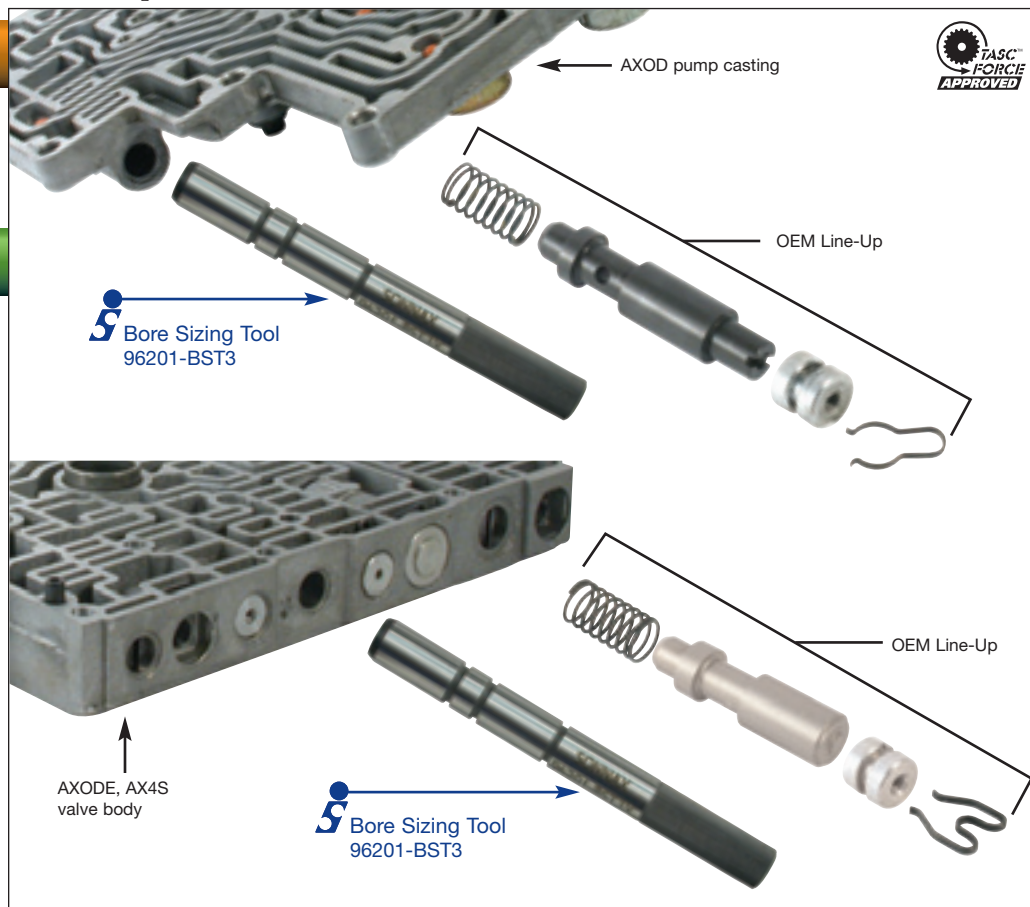
1 Bore Sizing Tool

Ridges in the 1-2 capacity modulator bore cause the valve to hang up and stick, resulting in insufficient accumulator control.

The Sonnax bore sizing tool allows the bore to be burnished to remove any ridges inhibiting correct valve movement.
