TECHNICALLY *Speaking*

Article No.: TCTIP-03-2009

Internal Clearance

Sometimes misunderstood, and often overlooked, but very important!

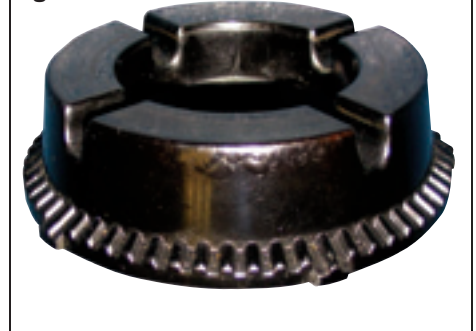
Figure 2

but too many were having the same problem. At one point a converter came back with the paint burnt but the converter had not yet self destructed. When the shop cut the converter open, the only thing they found that was out of the ordinary, was small blisters on the side of the stator cap.

The stator cap in **Figure 2** was in a low mileage rebuilt G.M. converter that was returned to a builder because of a transmission related problem. The blistering on the side of the stator cap was the result of .245" of internal clearance. This converter would have failed prematurely because of the incorrect internal clearance.

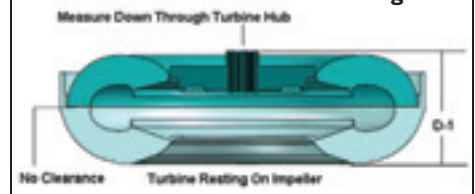
Figure 3

of the impeller, so the veins are in contact. In that position, there is no clearance between the impeller and turbine. Measure from the top of the turbine hub down to the flat surface and record your measurement. (**Figure 3**)
