Center Support/ Overdrive Shaft Sleeve Kit

56219-05K

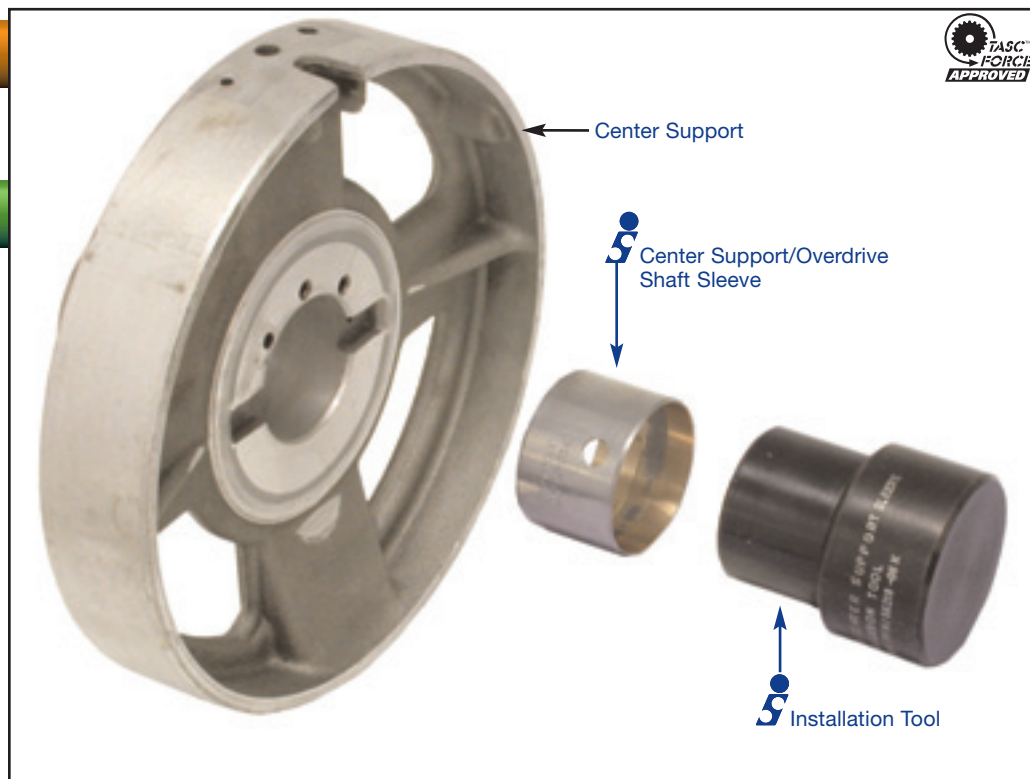
Delayed forward engagement, forward clutch failure

- Overdrive clutch retainer springs blow out

The overdrive shaft is not supported by the center support.

The A4LD is designed so the overdrive shaft is supported at its tip by the output shaft. The support is not adequate enough to prevent vibration of the overdrive shaft. Often, the lack of support for the overdrive shaft allows the overdrive sprag to contact the overrun clutch retainer, causing the retainer springs to blow out. Even if contact does not occur, vibration of the overdrive shaft is transferred to the forward clutch drum and causes increased wear between the forward clutch sealing rings and the center support. Eventually the wear leads to leakage of forward clutch oil. To correct the situation Sonnax has introduced a sleeve **56219-05K**.

This sleeve provides positive support for the overdrive shaft.

- Sleeve supports the overdrive shaft directly in the center support.
- Support sleeve greatly reduces movement of the overdrive shaft, which reduces wear at the center support.
- The **56219-05K** sleeve fits into the center support without any machining required to shaft or support.
- Sonnax also offers an installation tool for pressing the sleeve into the center support. The installation tool kit **56219-06K** includes a support sleeve.

Note: Following installation of the Sonnax sleeve, the tip of the overdrive shaft (where it fits into the output shaft) should be ground off. This eliminates the potential for binding that can occur by supporting the overdrive shaft in two locations.
