3-4 Accumulator Piston

84880M-01

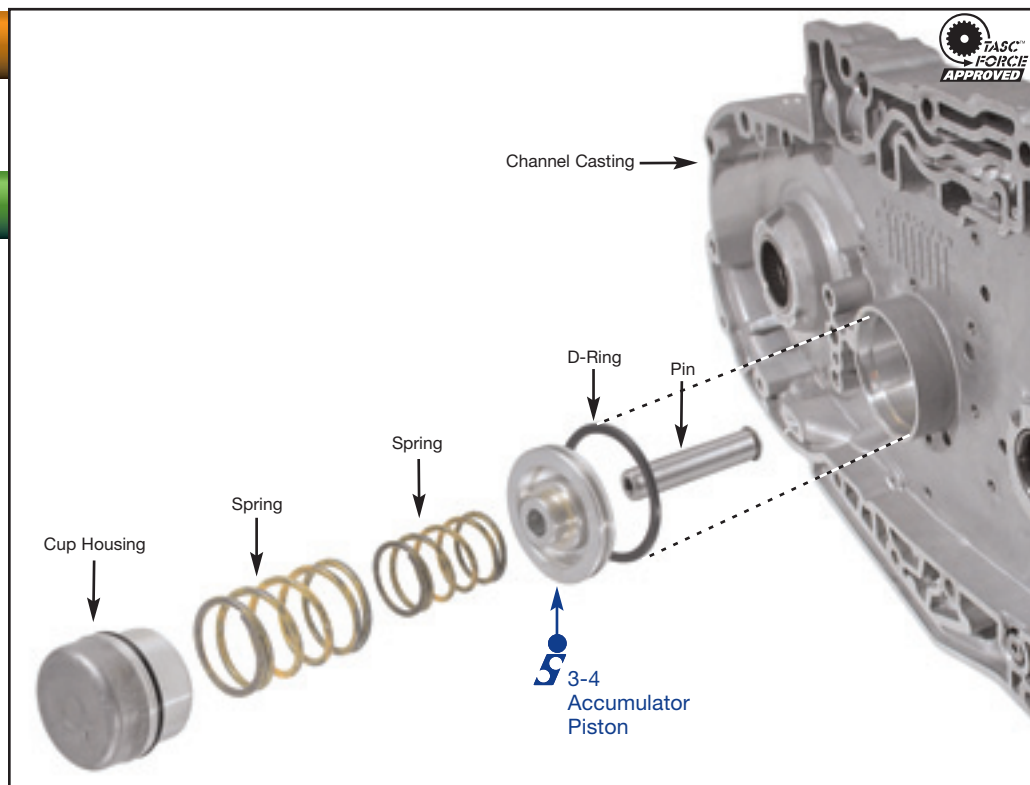
- Burned 4th clutch • No 4th gear • Soft 3rd gear

Wear at the 3-4 accumulator piston pin or bore.

It is common to have poor 3-4 shifts, no 4th gear or a burned 4th clutch in 4T65-E units. This can be caused by excessive wear at the 3-4 accumulator piston pin bore, which allows 4th clutch oil to exhaust and can result in harsh 4th, no 4th gear or a burned 4th clutch. Pin bore wear also reduces 3rd clutch pressure during 3-4 shift. The 4th shift quality depends on the condition of the piston and accumulator valves. If the 4th accumulator piston seizes, the 4th shift will be very hard. The Sonnax accumulator piston **84880M-01** restores accumulator pressure and eliminates cross leaks.

The Sonnax piston is made from high-grade billet aluminum to prevent wear and restores clearances at the pin.
