Center Support/Direct Drum Sleeve

56219-02K

Sonnax Part Summary

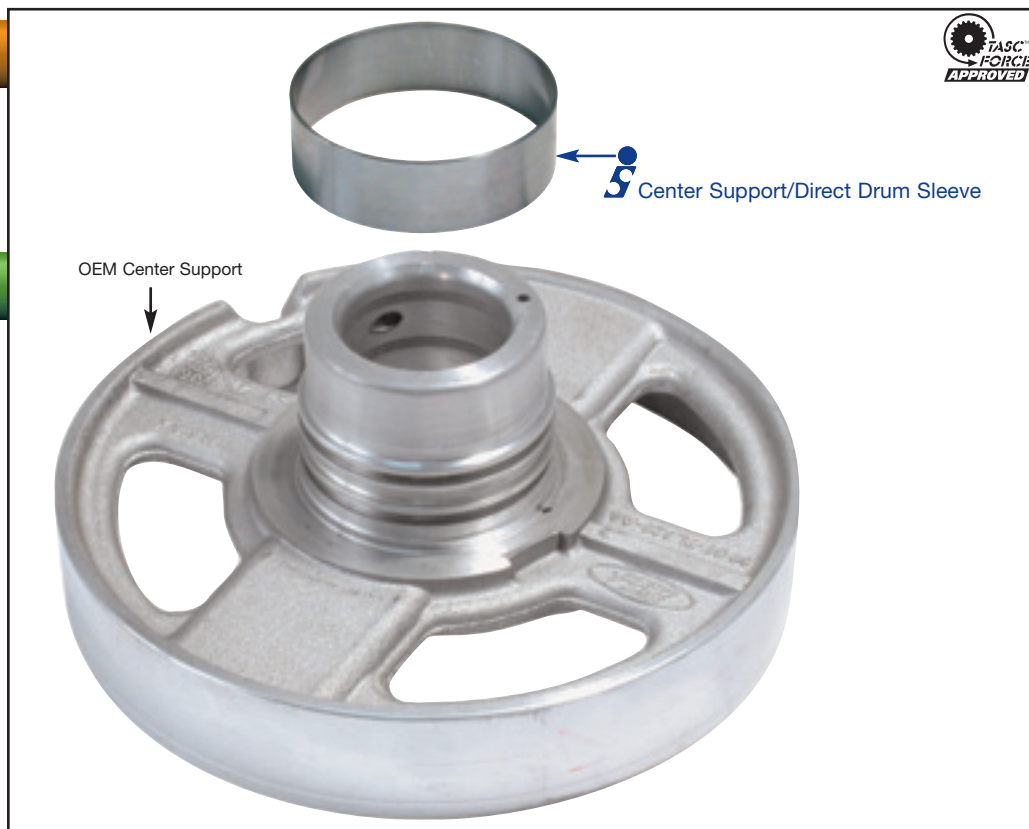
Burned forward clutch

- Loose sleeve • Loose fitting direct drum

The OEM sleeve stretches due to excess heat from the burned forward clutch, and there is too much clearance between the OEM sleeve and the direct drum bushing.

In A4LD, 4R44E & 4R55E units the center support has a steel sleeve that supports the direct drum. Heat from clutch failure expands both the center support and the steel sleeve. Because the center support is aluminum, it expands at about twice the rate of the steel sleeve. This can cause the sleeve to stretch permanently and become loose when the unit cools. Sonnax now offers a replacement sleeve **56219-02K** for a loose OEM sleeve.

This sleeve is a direct replacement for a loose OEM sleeve, and is also thicker to provide a tighter fit and better support for the direct drum.

Note: Fits '96 & earlier bushing style center supports only.

- The Sonnax sleeve is designed with a thicker wall thickness to provide more stability and better fit to the direct drum.
- This sleeve is recommended even if the OEM sleeve is still intact.
