## Aluminum 2-3 Shift Valve

### 77754-33

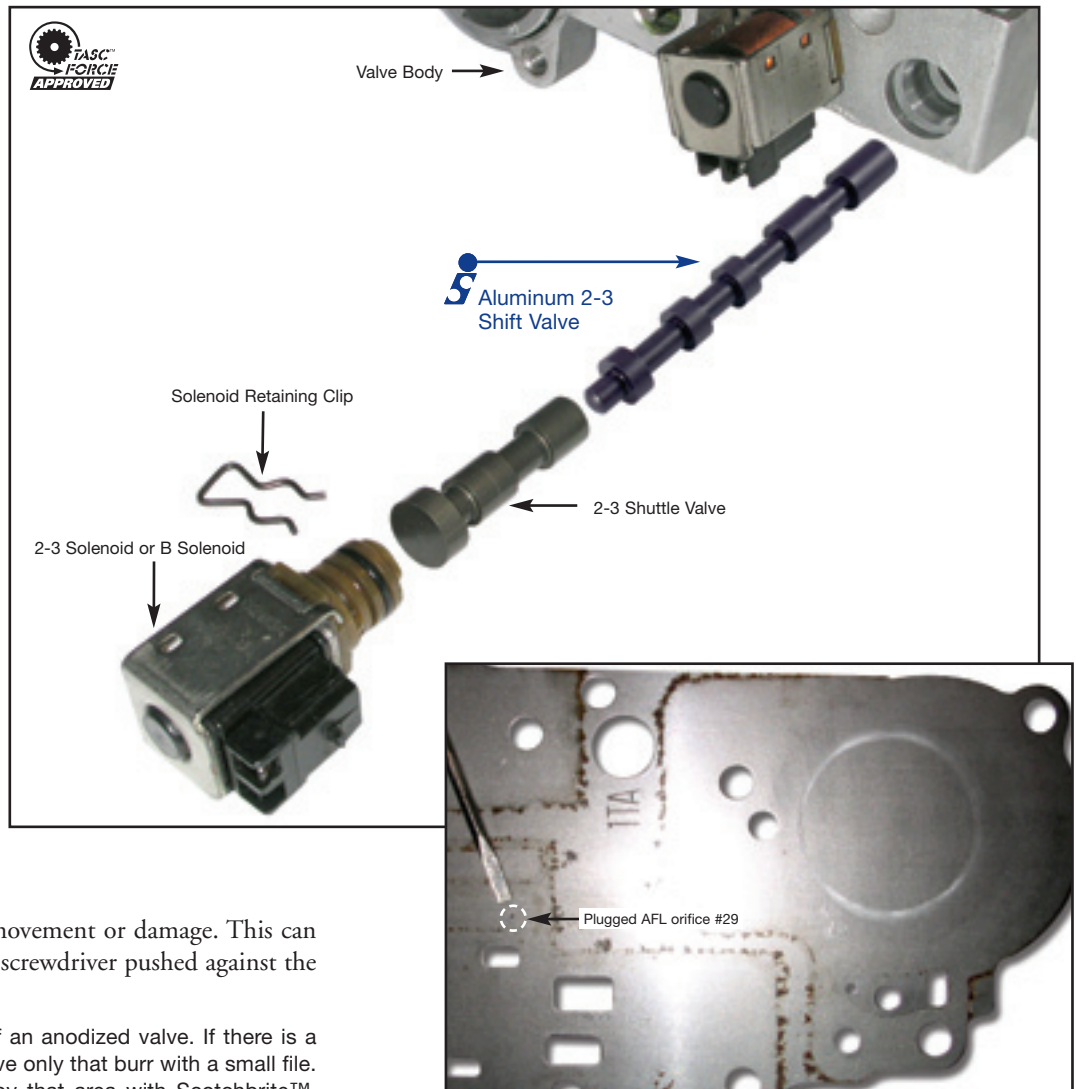
1, 2-3 Shift Valve

- Plugged AFL orifice #29 (see photo)
- Cracked or leaking 2-3 shift solenoid
- Low AFL oil pressure and circuit leaks
- Material build-up at the outer bore of the 2-3 shuttle valve (same bore as the outer valve)

1. Remove and discard the damaged or steel OEM 2-3 shift valve.
2. Install the Sonnax replacement valve, using the photo for proper orientation.
