Delay in reverse or slipping causing burnt clutches and bands

Reverse Boost Valve Kits

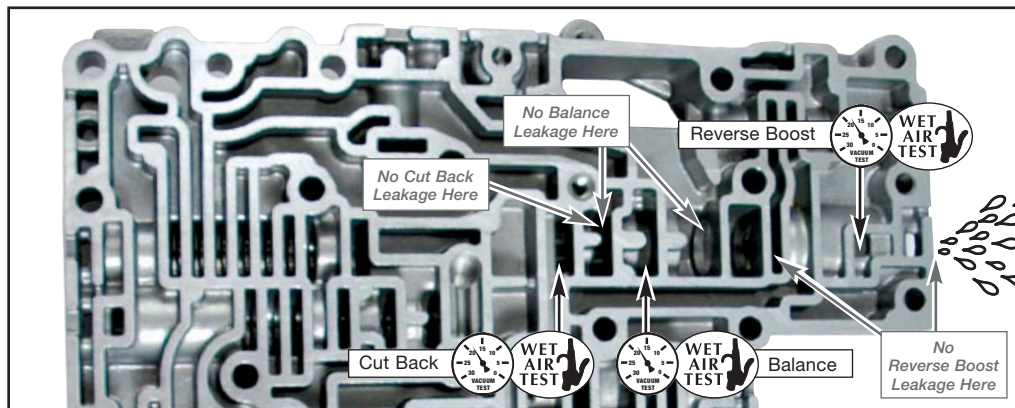
Either a Wet Air Test or a Vacuum Test in the location shown, results in leakage. A vacuum test must hold a minimum of 18".

Replace the worn boost valve assembly with the appropriate Sonnax boost valve assembly.
