Oversized Governor Pin & Test Tool

Sonnax Part Summary

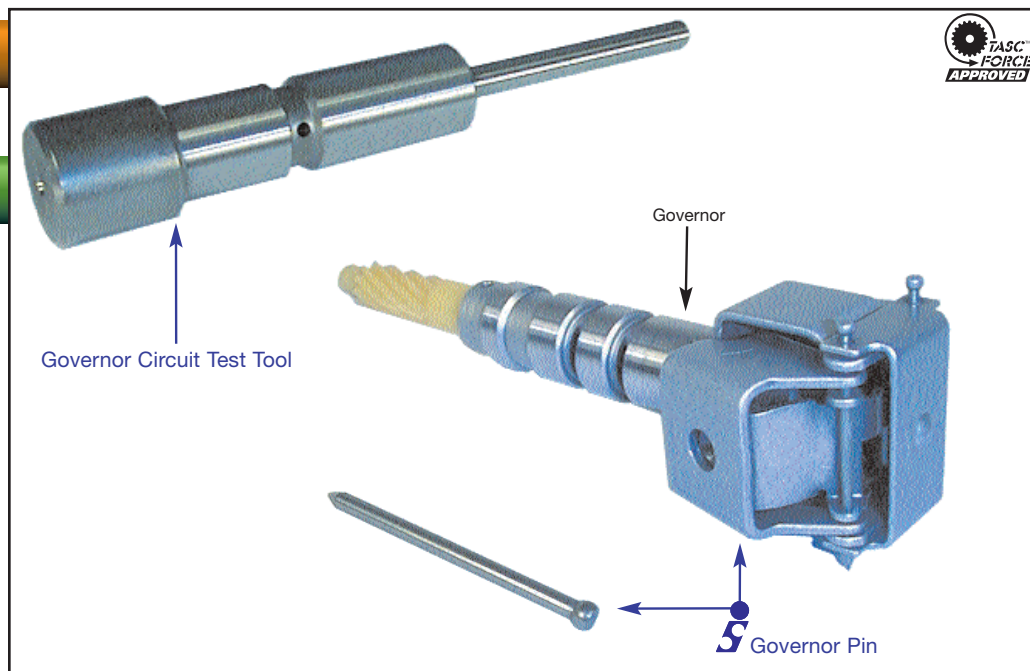
Erratic or no 1-2 & 2-3 shift

- Pin and weight hang up

The governor body and pins wear out.

Vehicles with an ATX transmission often have late, erratic, or no 1-2 and 2-3 shifts. This can be caused by wear of the governor body and pins that hold the primary and secondary weights. These weights wear grooves in the pin, causing them to hang up and open or close improperly. The pin holes in the weights also become elongated, preventing proper governor function. Sonnax now offers an oversized governor pin **86412-01** that allows the weights to move freely, while the Sonnax tool **86412-T** allows you to test for a variety of complaints.

This oversized governor pin allows the weights to move freely after the pin holes in the primary and secondary weights are drilled to accept the these oversized pins.

Note: The pin holes in the primary and secondary weights must be drilled to accept these oversized pins using a .125" or 1/8" high-speed steel drill bit. These are available either at your local hardware store or through most tool catalogs.
