COMPLAINT

Baseline Rebuilding Kit

37947-EZ

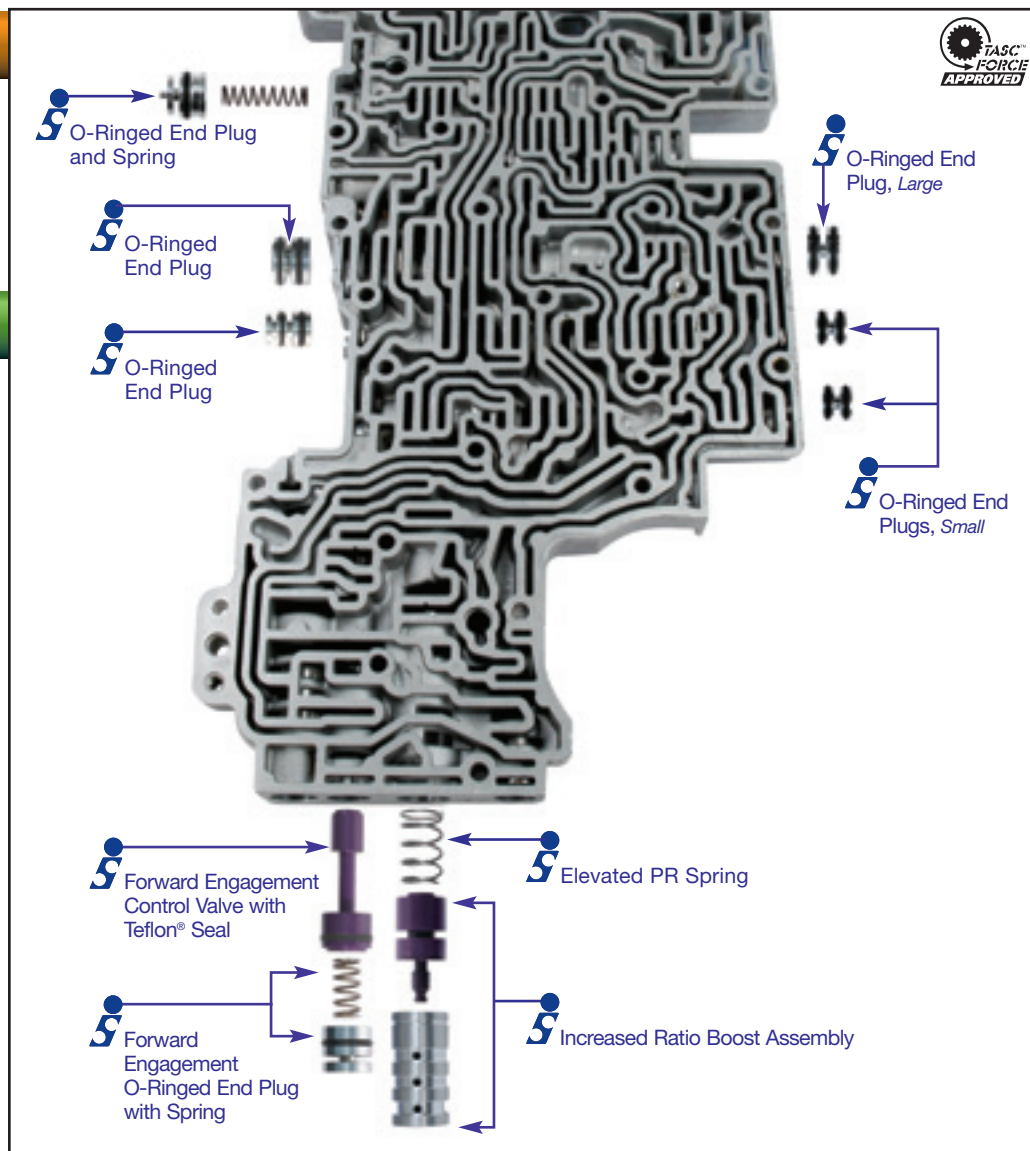
Leakage of EPC oil at multiple locations diminishes line rise and feed to the TCC circuit, resulting in pressure-related shift complaints, converter issues and trouble codes. Additional leakage in the solenoid oil circuit contributes to the various shift complaints.

This baseline rebuilding kit does not require tooling. The kit may be used as a standalone fix for lower mileage units that do not show bore wear in critical valve areas, or may be used in conjunction with additional Sonnax 4R44E/55E, 5R44E/55E solutions.

Note: Prior to installing this kit, it is highly recommended to inspect the valve body for wear beyond the scope of this kit. In the event of excessive wear in critical locations, this kit should be used in conjunction with the appropriate Sonnax valve kit. Inspection and testing procedures can be found on pages 106-109 of Sonnax Transmission Specialties™ Volume 6.
