Forward Clutch Hub Washer (Rear)

Sonnax Part Summary

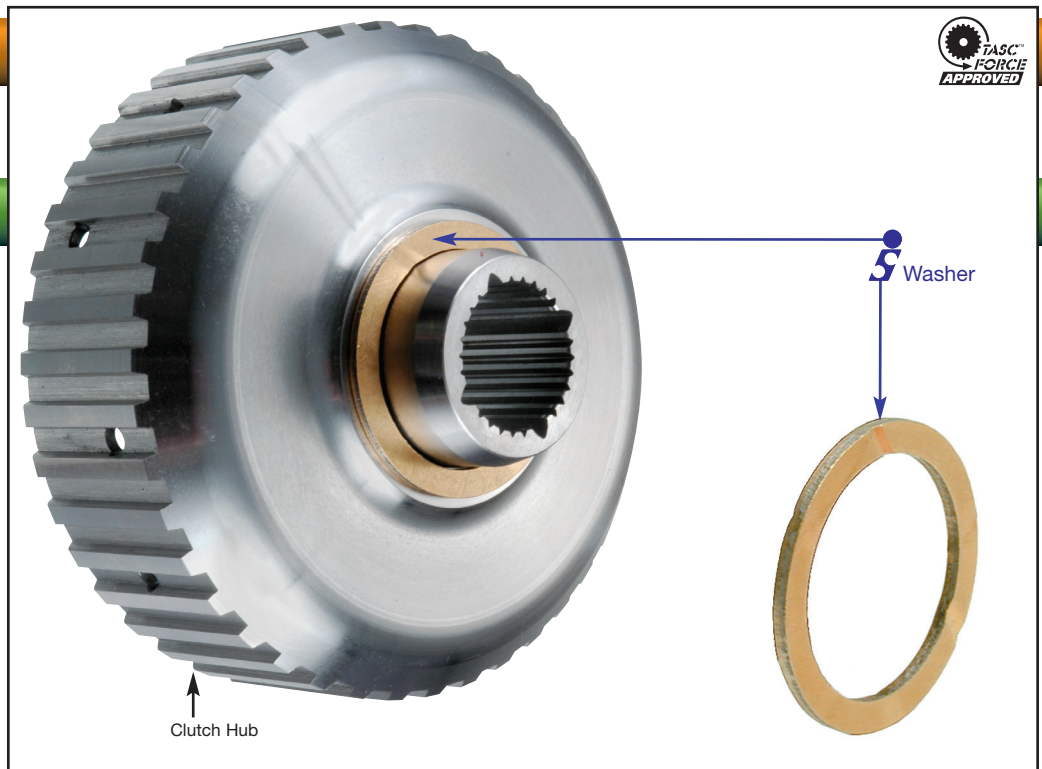
Forward clutch & sealing ring failure

- Excess front endplay • Reduced bearing, thrust washer, and sealing ring life

Worn components, machined hard parts, excess ring travel.

This thrust washer takes up play between the forward clutch hub and direct clutch housing, reducing wear and salvaging valuable hard parts.

A pump that has been resurfaced or accumulated shaft spline wear creates excessive endplay of the forward and direct drums. This reduces sealing ring, clutch, bearing, and thrust washer life. Having the ability to shim both the lower unit sun gear with Sonnax shim **34500-Z** on '96 and earlier units and washer **34301-078** or **34301-094** on all units addresses these problems.

- Washer **34301-078** (.015" oversized) and **34301-094** (.030" oversized) take up the play between the forward clutch hub and the direct clutch housing, allowing front unit endplay to be reduced.
- Washers also stabilize the direct drum, reducing delayed reverse and improving 2-3 clutch circuit.
- Allows salvage of valuable hard parts.
