"A" Servo Spring

76831-SP

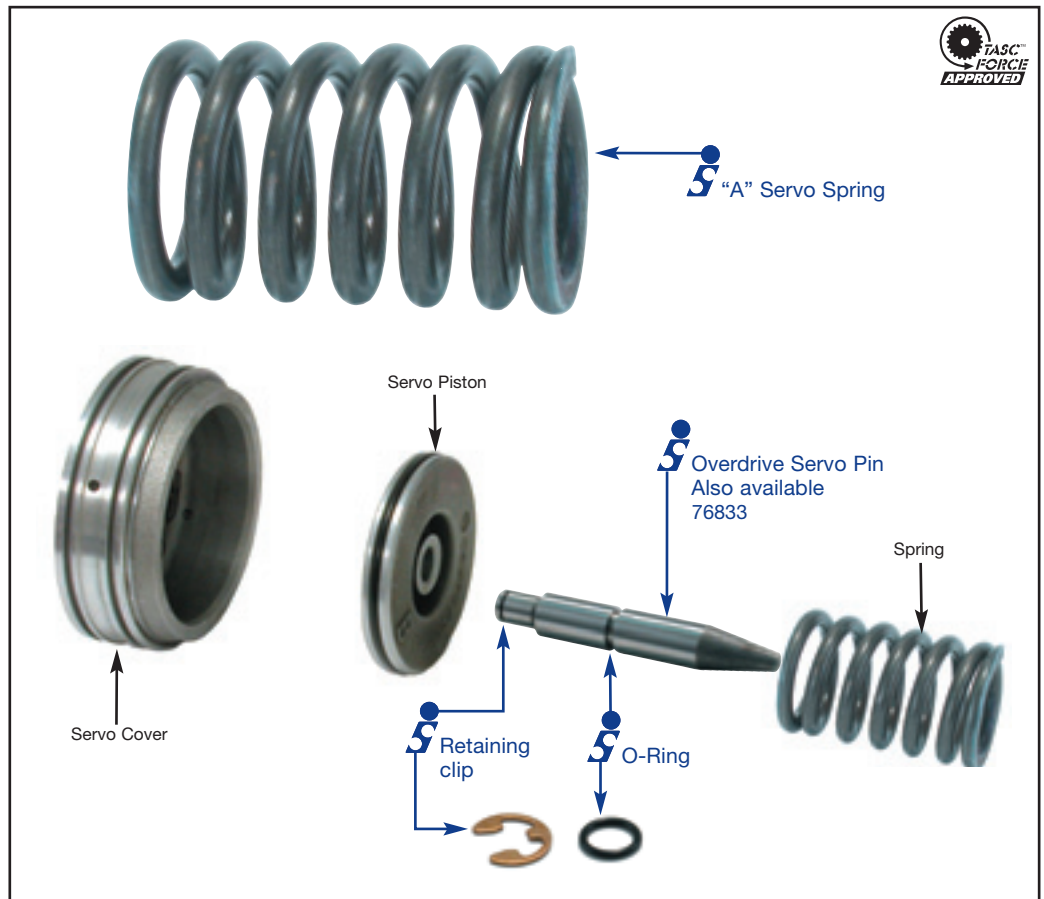
The OEM green spring for the "A" servo is not strong enough, allowing the overdrive band to apply before the forward clutch releases. This replacement spring increases the spring rate almost 30% over the OEM spring, which provides more strength and prevents premature apply of the overdrive band which creates a 3-4 shift tie-up.

Simply replace the existing servo spring with this stronger spring. Verify that the tip of the piston assembly engages the band pocket when reassembling.
