## COMPLAINT

### O-Ringed Valve End Plug Kits

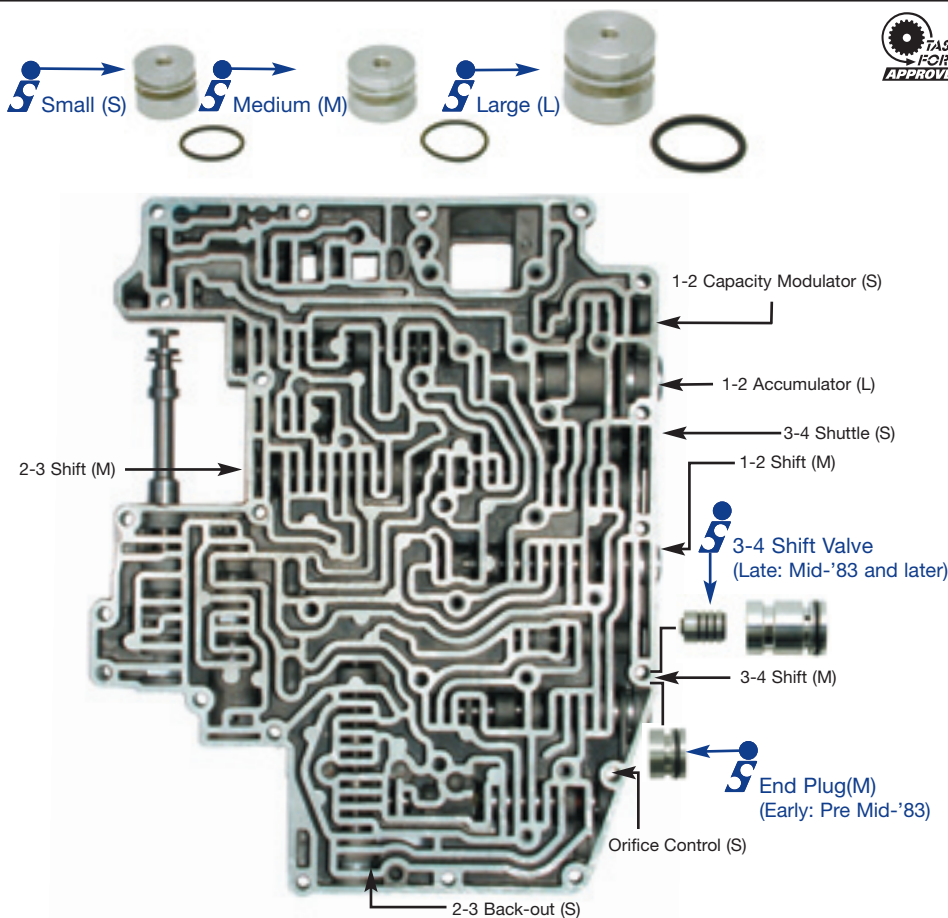
Erratic shift timing, oil leakage

Leaking valve end plugs in pre mid-'83 units, or worn 3-4 shift valve and sleeve in mid-'83 and later units.

Plugs are manufactured of high-quality aluminum to resist wear. The o-ring on the outside diameter prevents leakage between the plug and the valve body. The medium 3-4 plug is replaced by the 3-4 shift valve assembly after mid-'83.
