Reverse Boost Valve Sleeve

34200-09K

Sonnax Part Summary

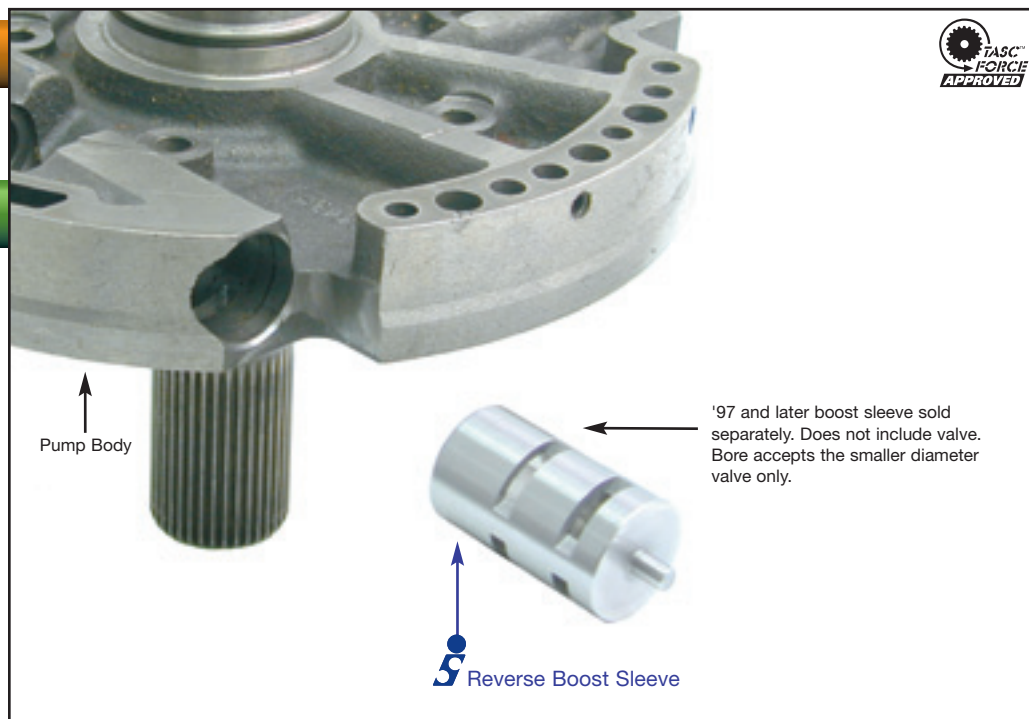
High line in reverse, broken cases

- Uncontrollable Line Rise, • Buzzing noise • Broken Direct clutch drums

Excessive cross leakage due to wear of the sleeve.

Common problems in vehicles with a 4L80-E transmission are uncontrollable line rise (upward of 500-600 psi), high line pressure in reverse, buzzing noise, broken direct clutch drums and/or broken cases. These problems are usually caused by reverse boost oil that enters the torque signal circuit due to a worn boost valve sleeve. The Sonnax replacement sleeve **34200-09K** eliminates these problems.

This replacement sleeve fits the latest boost valve size (.830" reverse spool diameter), restoring the correct clearance and preventing valuable oil leakage.
