## Accumulator Bore Sleeve Kits

### Sonnax Part Summary

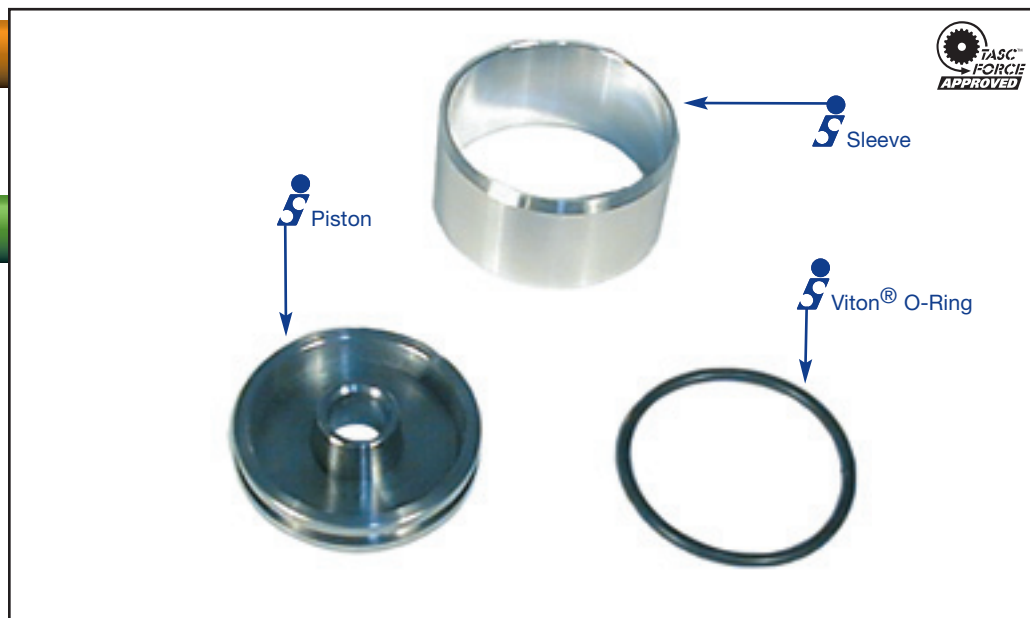
Scored accumulator bores create loss of clutch pressure or cross leaks.

The accumulator bores on AXOD & E, AX4S channel castings can become scored, which creates loss of clutch pressure or cross leaks. The continuous oscillation of the piston within the bore causes excessive wear. Also a broken accumulator spring can get caught between the piston and the bore causing a deep groove in the casting wall. You can resolve these problems by installing these Sonnax AXOD & E, AX4S accumulator bore sleeve kits.

The accumulator bore sleeves are made from wear-resistant aluminum and the length of the piston-to-pin contact area has been increased to reduce piston cocking and increase sealing surface area.
