O-Ringed Accumulator Piston & Spring Kits

Sonnax Part Summary

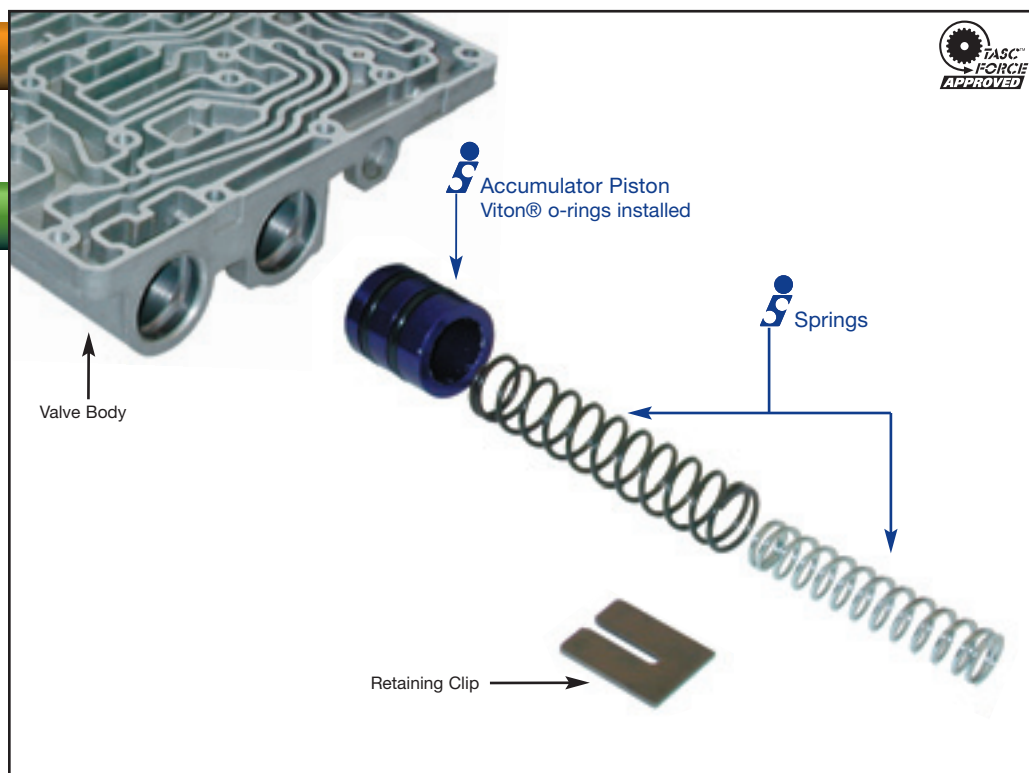
Accumulator bore wear and/or piston sticking

CD4E transmissions may exhibit such problems as harsh engagements, and/or soft or harsh shifting, particularly from first to second gear. These complaints can be due to worn or out-of-round accumulator bores and/or pistons sticking in the bore. Sonnax now offers an accumulator piston kit **73840-24** for the 2-4 piston, **73840-LR** for low/reverse, and **73840-FWD** for forward.

Prevent leakage of worn valve body castings with this o-ringed accumulator piston and spring kit.

- Anodized aluminum pistons have two o-rings that prevent blow-by leakage.
- Pistons have been dimensionally modified to stop in different axial locations to prevent them from hanging up or sticking on the previously worn bore edges.
- Modified replacement springs are included to fit the smaller piston pocket.
- Kits available for 2-4, low/reverse and forward locations.
