2-3 Accumulator Piston

72871-01

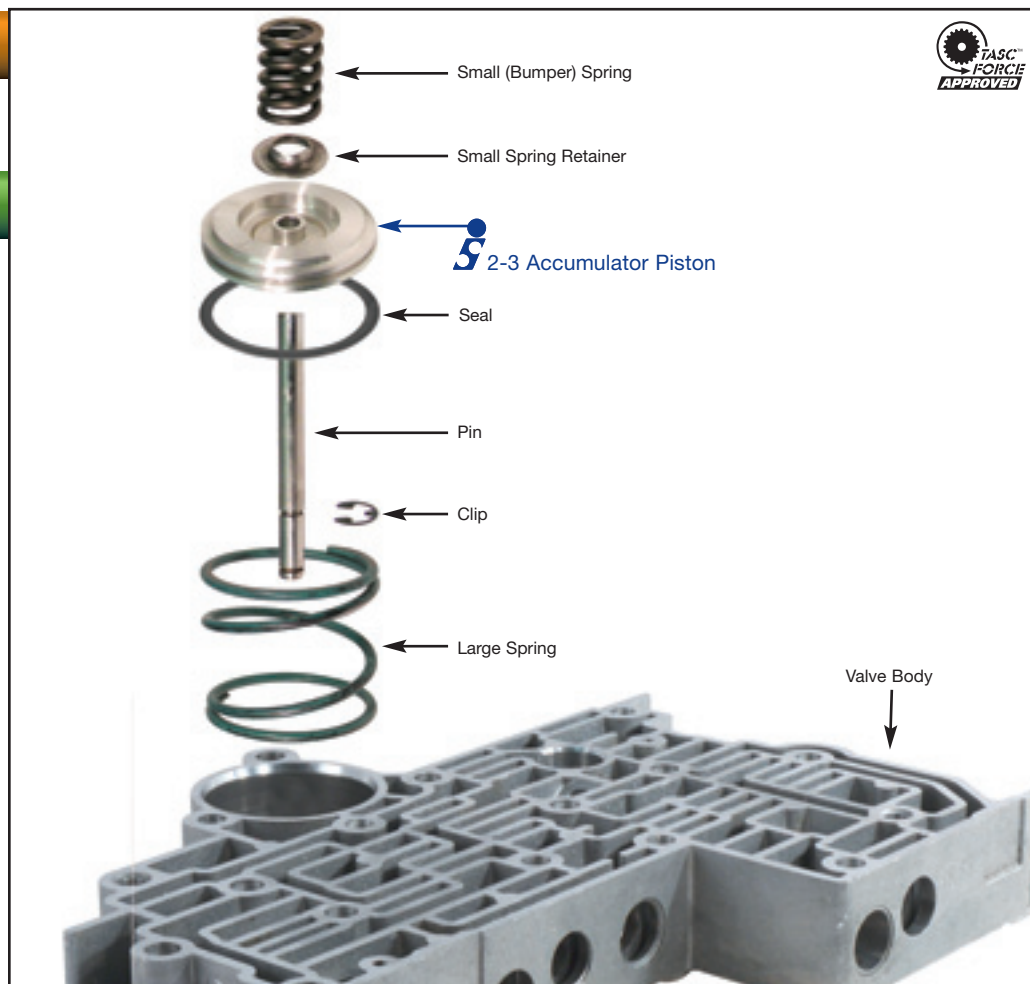
Worn accumulator piston pin bore or damage from broken spring

- 3rd clutch distress
- Soft 2-3 upshift or 4-3 kickdown

Normal wear and uneven loading from spring.

Install the Sonnax replacement piston with increased bore length for more piston-to-pin support and greater durability.

- This piston should not be used in a first-design 2-3 accumulator found in 1993 models. These units do NOT have the second "bumper spring" on the top portion of the accumulator piston.
- If the large spring is broken, replace with GM part number 8684827
