Universal Stator Support Shaft Kits

Sonnax Part Summary

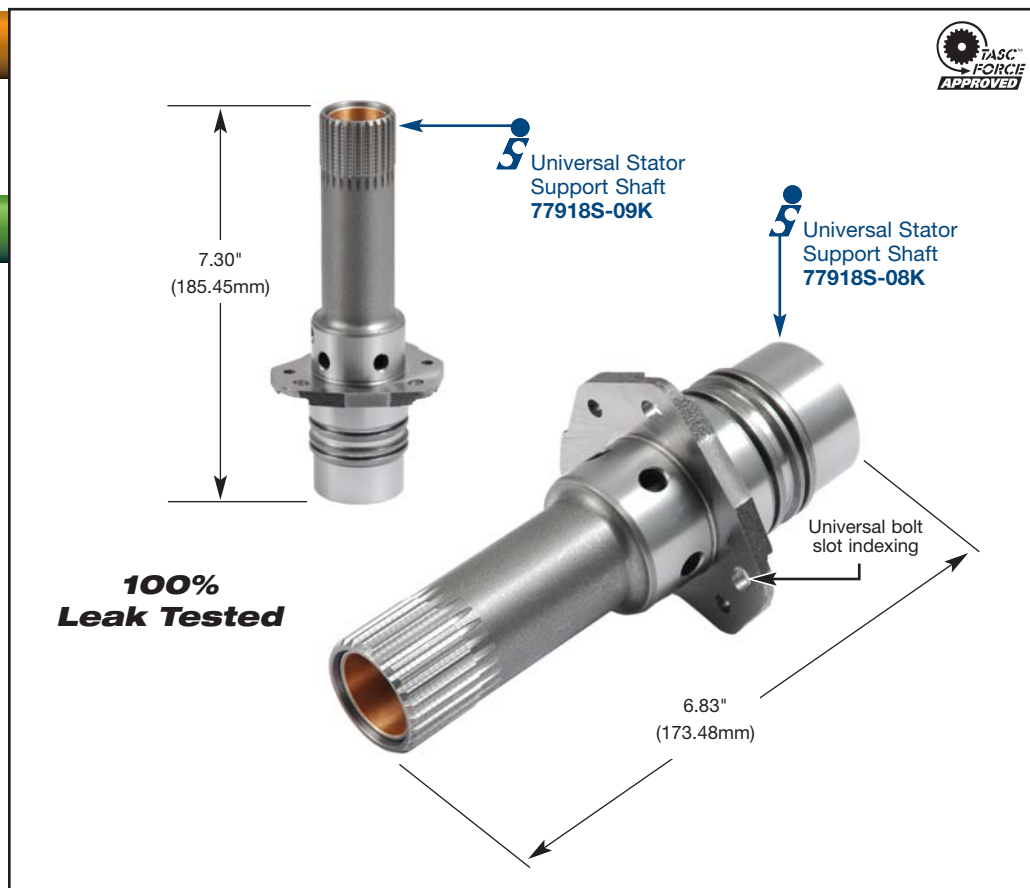
Delayed reverse, code 1870

- No 3rd gear • 3-4 clutch failure • Converter overheat

Overheating and manufacturing flaws cause sleeve rotation and block oil flow, which leads to transmission failure.

Current aftermarket replacement shafts are known to have several problems that can lead to transmission failure. The internal sleeve can rotate, blocking oil flow. The internal passages can cross leak. Metal chips can be hidden inside that cause transmission damage when oil flow carries them throughout the transmission. Sonnax now offers OEM replacement stator support shafts, 77918S-08K & 77918S-09K, with bushings. Each shaft is 100% leak tested to ensure the highest quality.

Replace worn or damaged stator shaft with this universal stator support kit.
