Part Summary Data Sheet

AISIN AW TR-60SN

PART NUMBERS 25741-11K, F-25741-TL11

Secondary Pressure Regulator Valve Kit

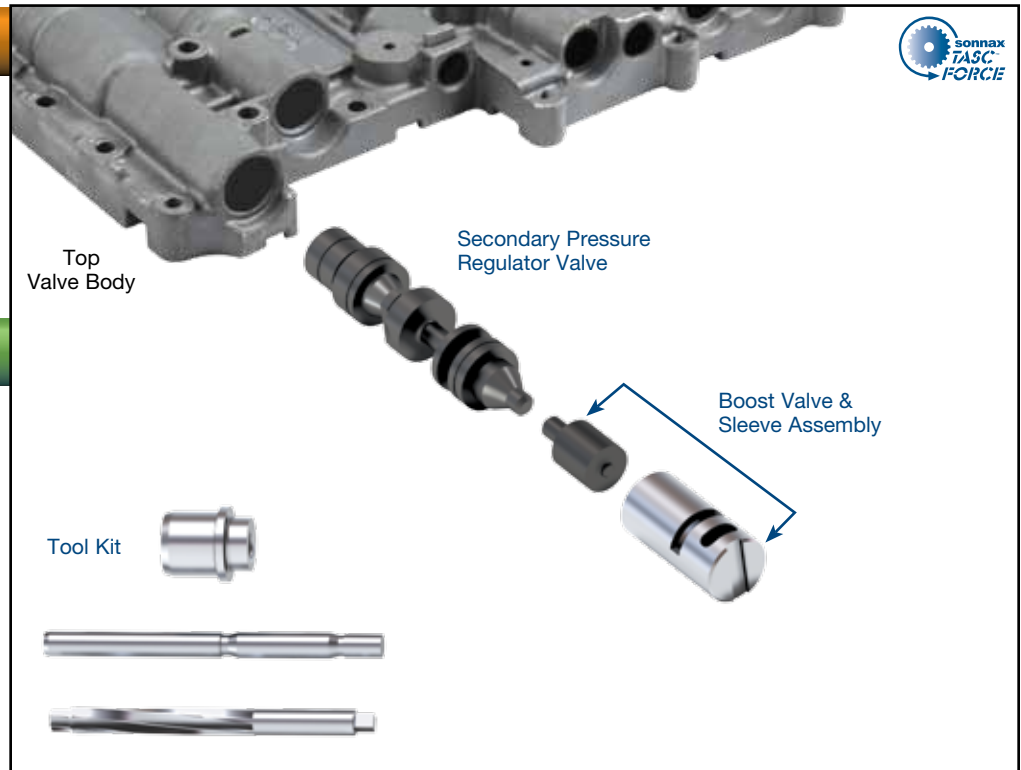
Bore wear at the spring end of the valve allows the SLT circuit and regulated converter pressure to cross leak. Bore wear at the balance end of the valve reduces converter and lube flow. Boost sleeve wear results in converter pressure bleeding into and elevating EPC.

A worn secondary pressure regulator valve in vehicles with an Aisin AW TR-60SN, VW/Audi 09D transmission can cause several problems. Overheating the fluid, bushings, and torque converter can all be caused by a worn secondary pressure regulator valve. Drivability issues include harsh reverse engagement, TCC slip resulting in RPM surge, and poor shift quality. Sonnax kit **25741-11K** is designed to correct the pressure outputs from the secondary pressure regulator valve and fix these drivability issues.

The Sonnax valve and boost assembly corrects circuit pressure loss and restores control over the secondary pressure regulator valve and boost valve function.

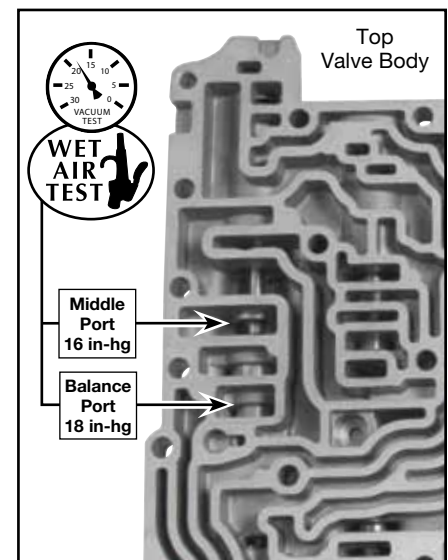
A vacuum test fails to yield the indicated 16 or 18 in-hg or greater, depending on the port tested as shown, or if visual wear is detected.
