Wiring Harness Connector Bracket

77980-01K

34998-01K

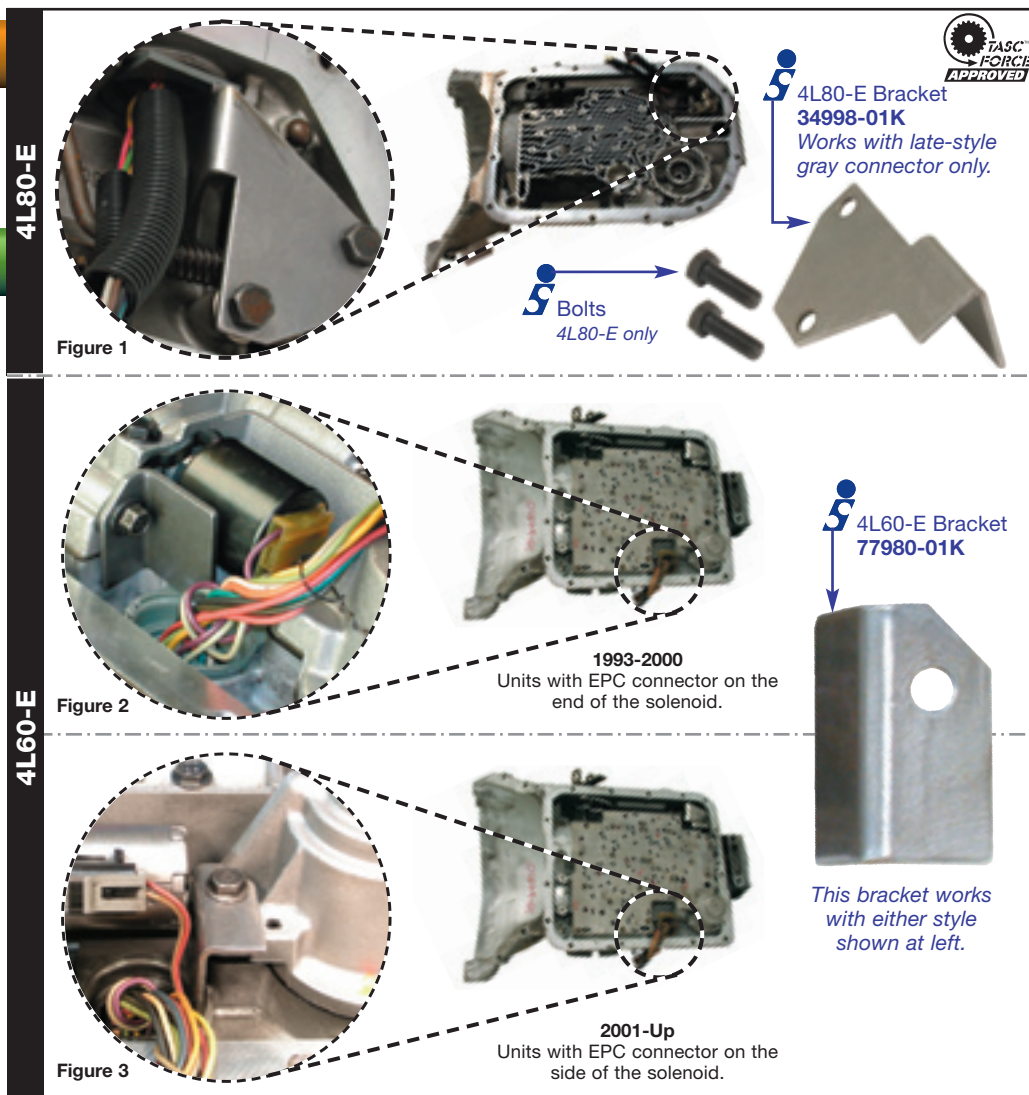
Connector pushed into pan area

- Retention tabs break off wiring harness connector

The plastic retention tabs that hold the wiring harness connector in place are easily broken, which can cause the connector to push into the case.

This metal bracket positively supports the connector and prevents it from pushing into the case even if the plastic retention tabs are broken.
