Lockup Control Sleeve & Plunger Kit

113741-11K

NOTE: Fits JF010E & JF011E

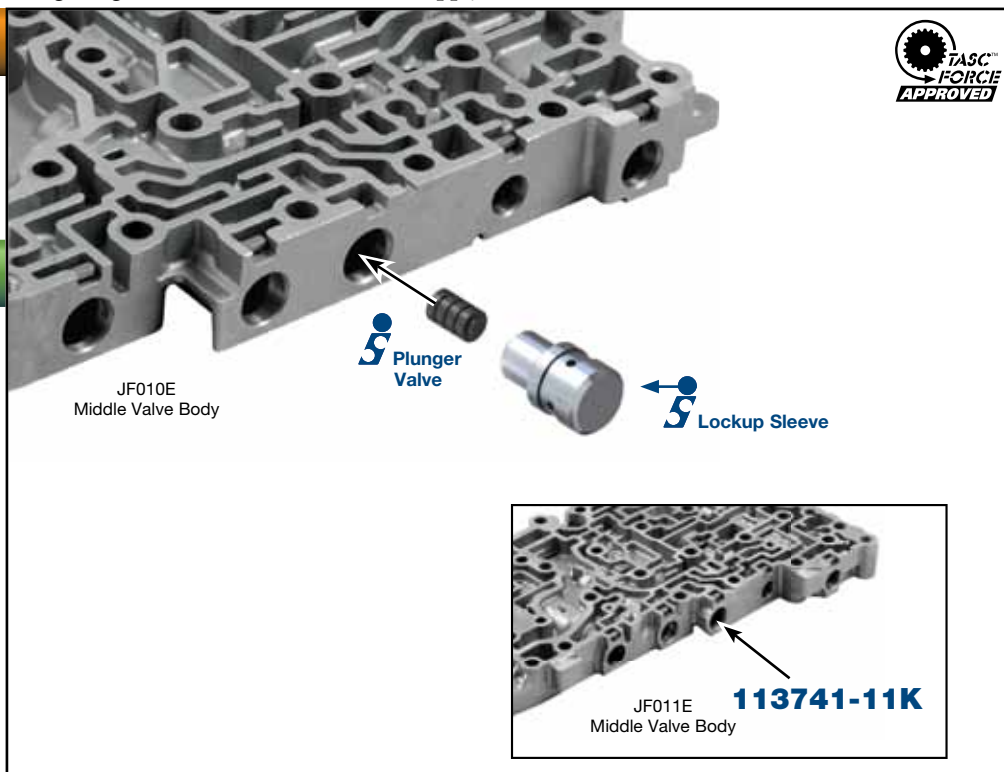
Jerking on coast down and/or harsh engagements

- High engine RPM when TCC fails to apply

The OEM lockup sleeve and plunger wear allowing hydraulic pressure to escape. The reduced or absent pressure affects the timing and quality of the lockup clutch apply and release action.

Replace the worn OEM lockup sleeve and plunger with Sonnax drop-in components.

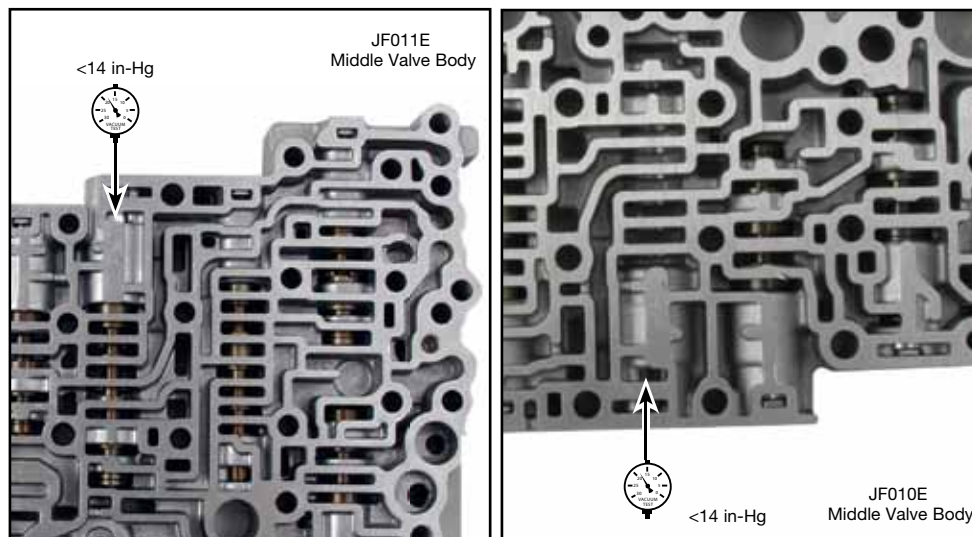
Vacuum testing at designated test point indicates less than 14 in-Hg.
